# Listing and Assessment of Heritage Buildings in Serampore's Historic Core

Final Report

Research Consultant  
School of Ecology, Infrastructure and Human Settlement Management  
Indian Institute of Engineering Science and Technology, Shibpur, West Bengal, India

August 2016

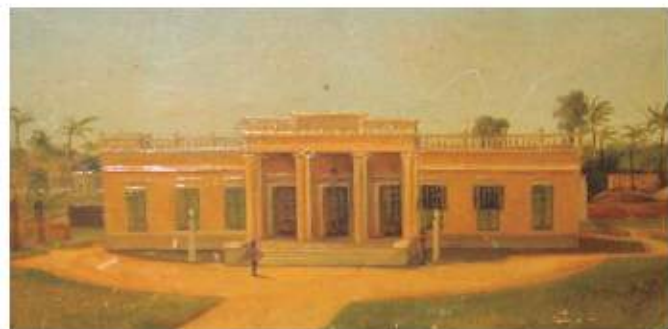
Danish Government House (Thomson 1827 (top), Hohlenberg 1830 (bottom) in Aalund and Rasten 2010 – North Facade

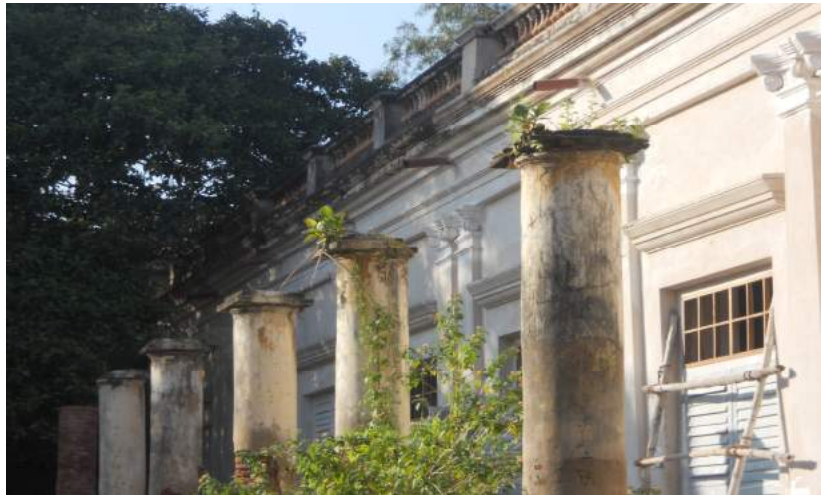
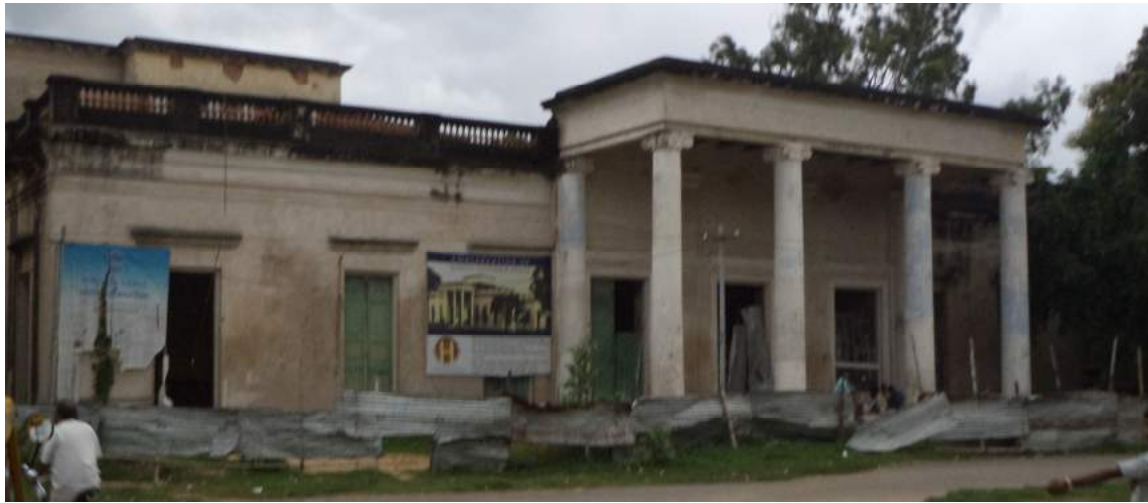
*The Danish Government House, Serampore Court Compound*

**Condition assessment** : Restored in 2013. Presently well maintained and in good condition.

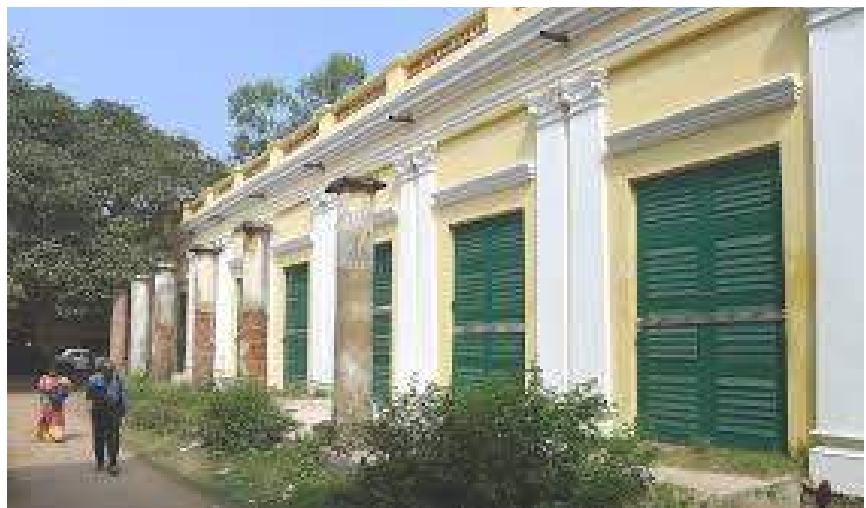
*The South facade after restoration*

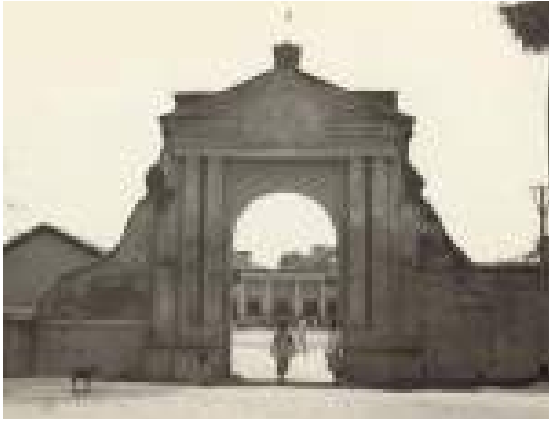
*The North Gate 1949 ( Photograph by N. Anderson MMD)*

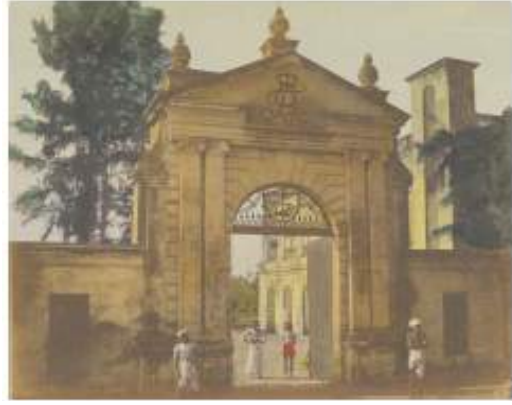
*The North Gate (Undated colour photograph, British Museum in Aalund and Rasten 2010)*

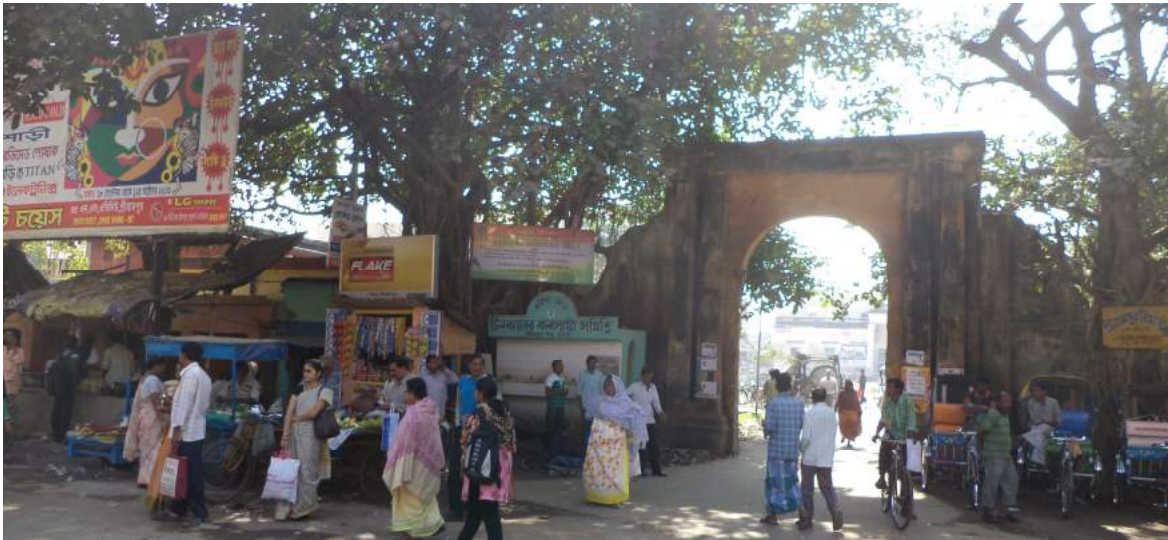
*The North Gate, Serampore Court Compound*

<b>Previous and existing utilization</b>	: Northern (riverside) entry/exit point to the then Government compound (Serampore Court compound at present).
<b>Architectural and special features</b>	: It was a well proportioned gateway building placed symmetrically on the middle axis of the northern side (riverside) of the then Government compound. The richly ornamented northern façade had paired pilasters with Ionic capitals and triangular pediments of the classical order. The impressive and richly ornamented gate had the monogram of the Danish King Frederick VI, who ruled Denmark during 1808-38.
<b>Condition assessment</b>	: The gate no longer displays its authentic architectural style and order and, is in dilapidated condition. Of late (2015) it has been included for restoration under the schemes of Serampore Initiative of National Museum of Denmark.
<b>Statement of conservation significance</b>	: Restoration of the North gate would contribute significantly to the historicity and ambience of the Government Compound and its immediate surroundings.

*The North Gate 2016: View from High Street (top)*

*View from Court Compound (bottom)*

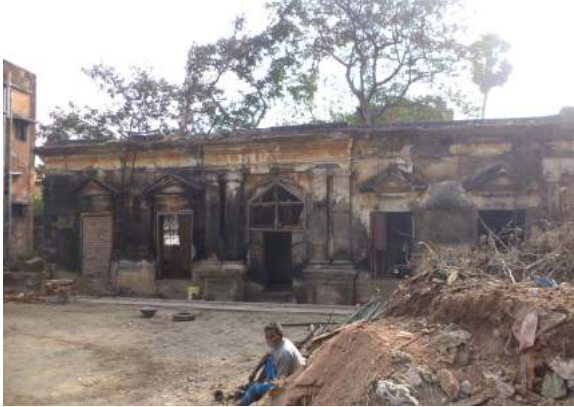
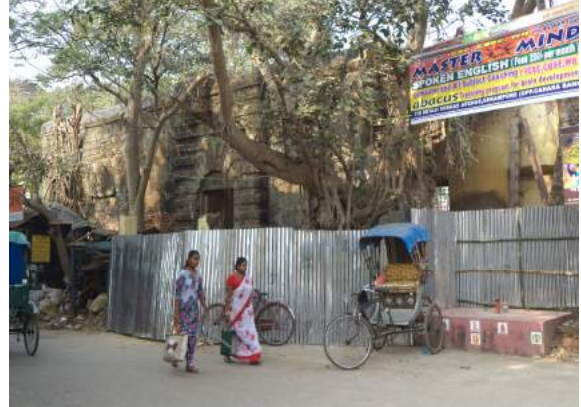
- Condition assessment** : Recently renovated and thus in a good condition. However, the building and its surroundings would require regular maintenance for the protection of its sanctity and the ambience.

*South gate before restoration*

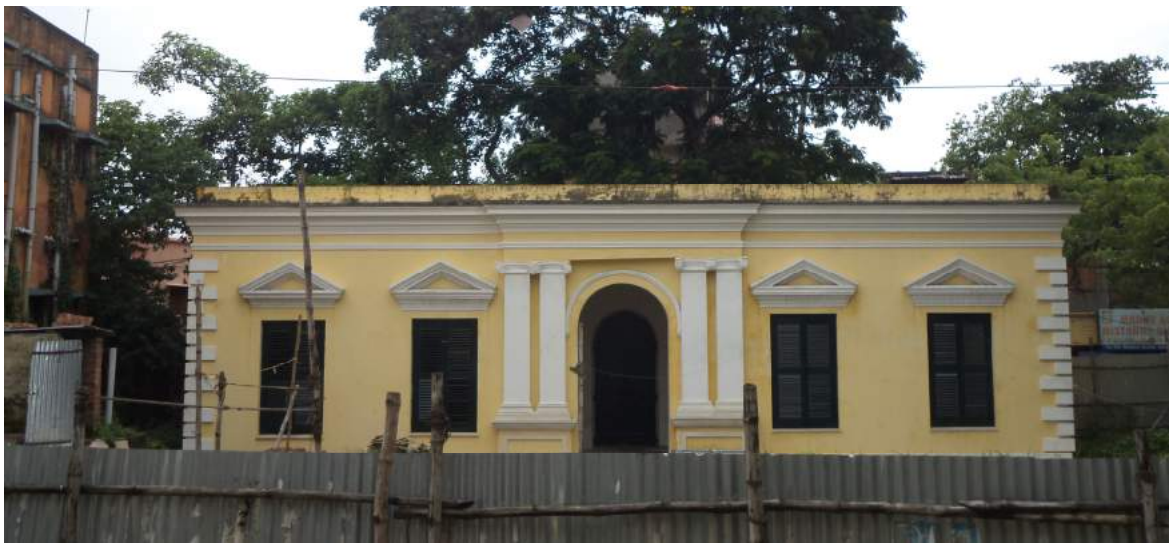
***The South Gate, Serampore Court Compound***

- Architectural and special features** : It is a small and very well proportioned building with building with a perfectly symmetrical layout around the middle axis of the compound. The richly ornamented northern façade have paired pilasters with Ionic capitals and triangular pediments of the classical order above the window openings. To the south, the gateway is emphasised by rusticated masonry.

*North façade after restoration in 2015*

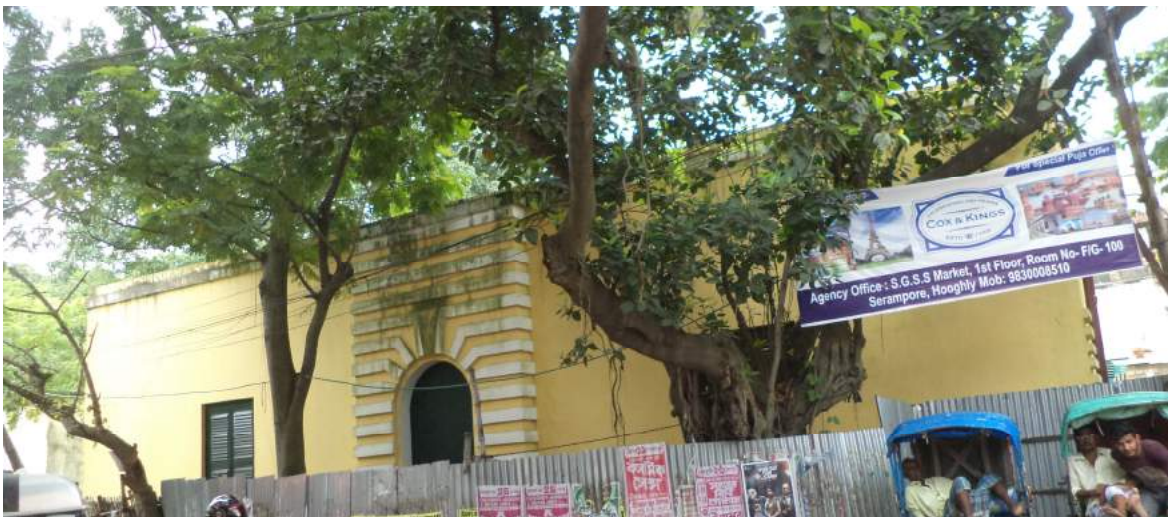
*South façade after restoration in 2015*

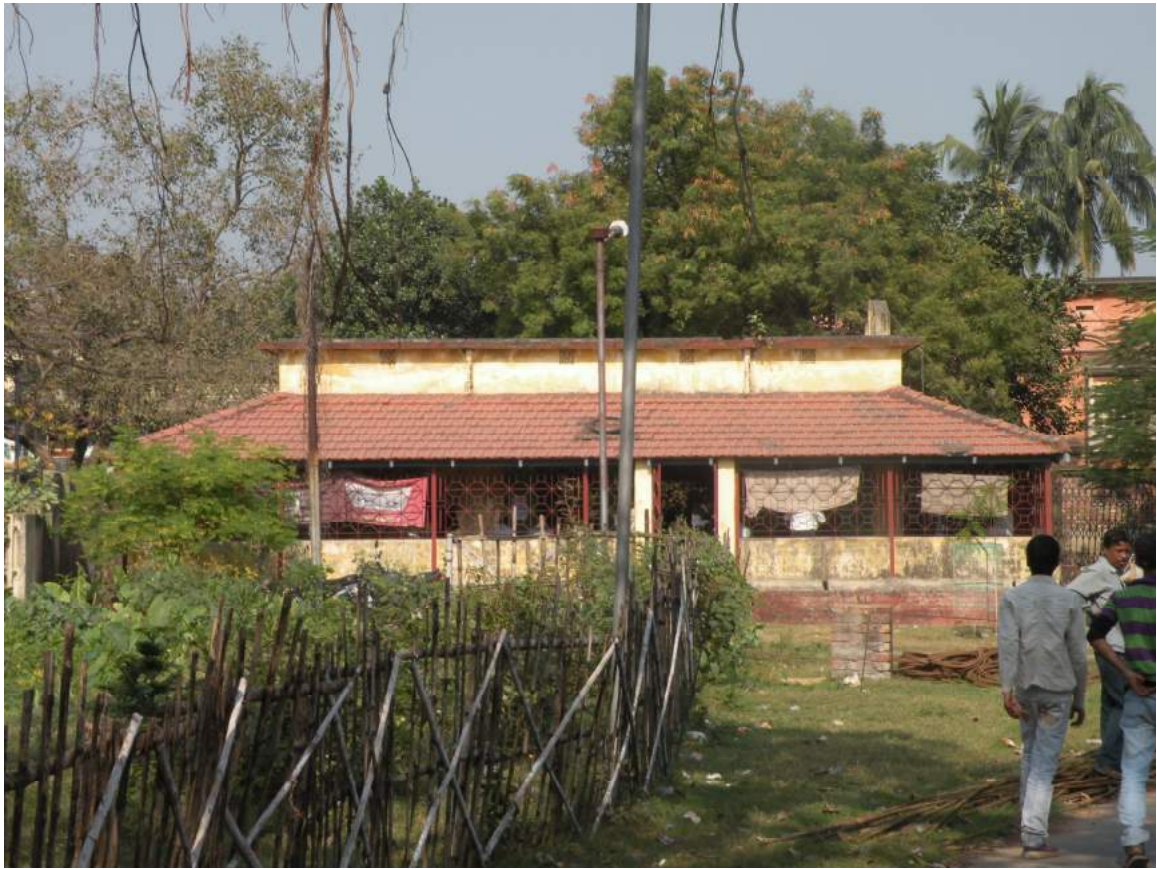
***The Bar Association, Serampore***

<b><i>Architectural and special features</i></b>	: A low single storied brick building painted in pale yellow colour with a red base surrounded by a red open verandah with tile covered lean-to roof. Traces of later alterations are observed in the gratings along the outer periphery of the verandah
<b><i>Condition assessment</i></b>	: Fairly good condition. Need for regular maintenance of the building with its surroundings
<b><i>Statement of conservation significance</i></b>	: European influenced traditional bungalow typology contributing to the historicity and pleasing visual order of the Government Compound.
<b><i>Grade</i></b>	: IIA

*View from west*

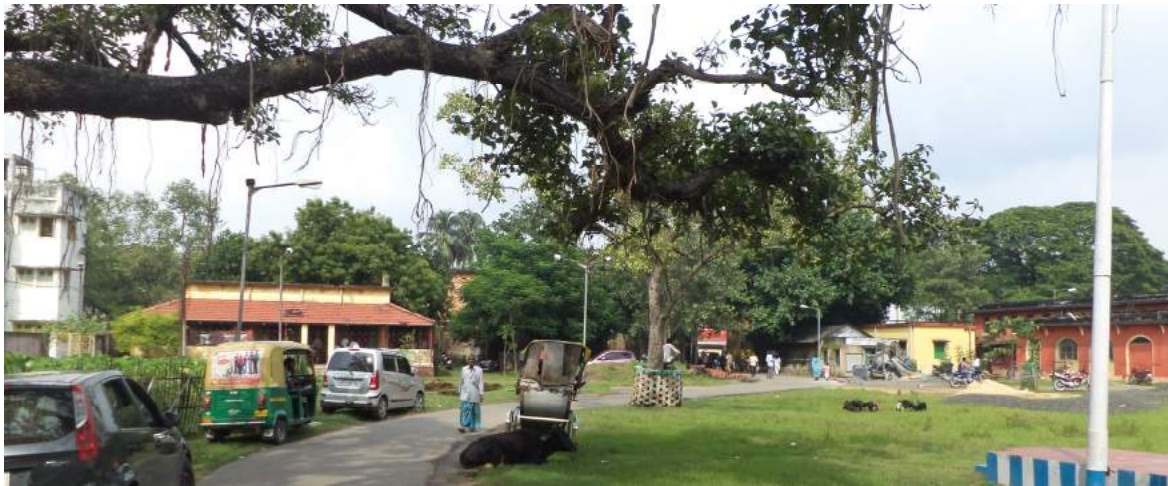
*The Bar association and its surroundings*

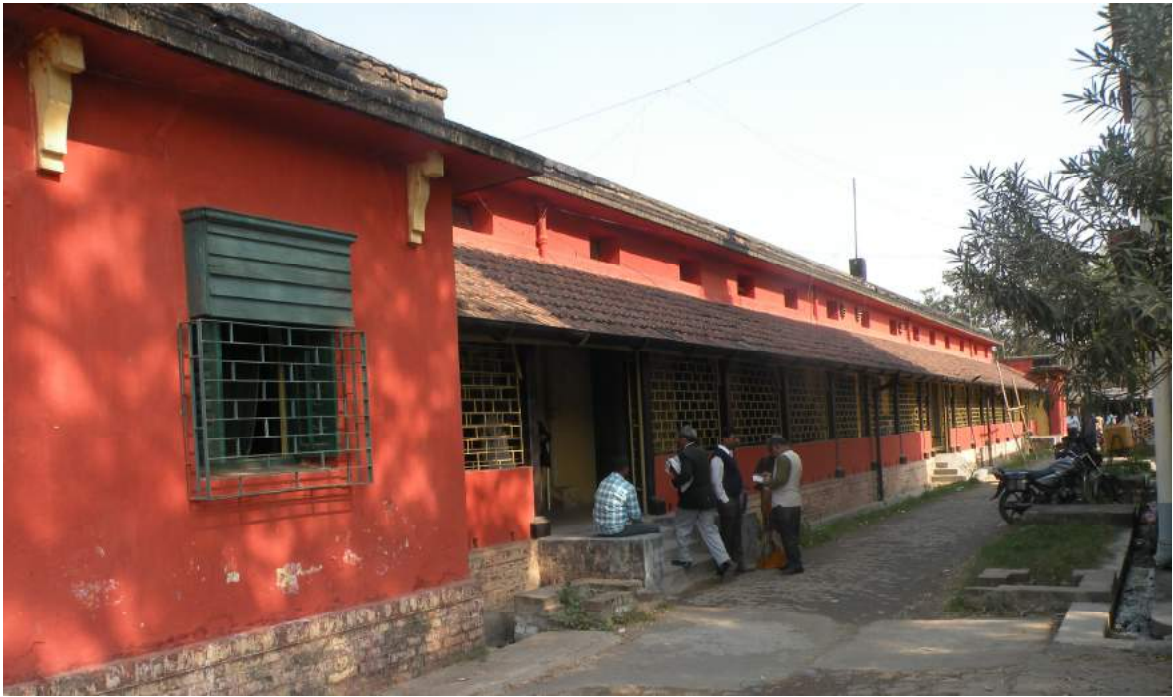
***The Court of Judicial Magistrate, Serampore, Hooghly***

<b>Previous and existing utilization</b>	: The initial utilization of the building is subject to investigation. At present the building houses the Court of Judicial Magistrate, Hooghly.
<b>Architectural and special features</b>	: Long single storied brick building painted in red colour with open verandah around and tile covered lean-to roof. Segmental arches are observed on the eastern façade. Traces of later alterations are observed in the gratings fitted along the outer periphery of the verandah and its further extension.
<b>Condition assessment</b>	: Fairly good condition. Need for regular maintenance of the building with its surroundings
<b>Statement of conservation significance</b>	: European influenced traditional bungalow typology contributing to the historicity and pleasing visual order of the Government Compound.
<b>Grade</b>	: IIA

*View of the entrance (west façade)*

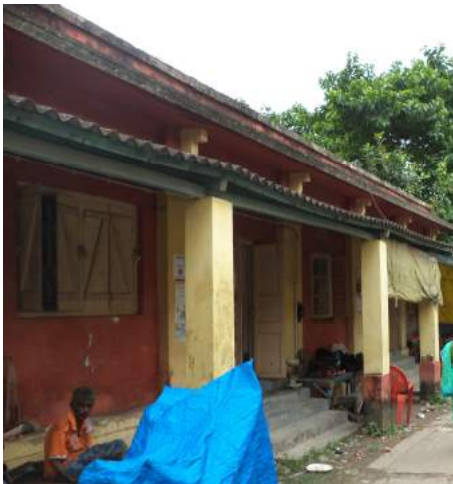
*Traces of later addition*

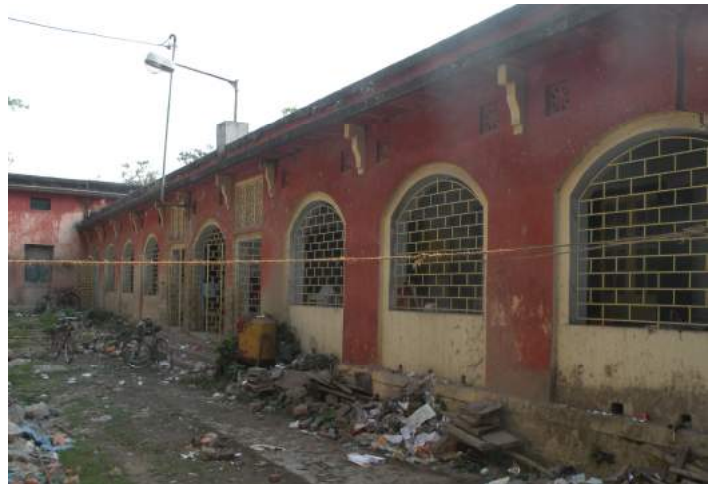
*View of the east (rear) façade*

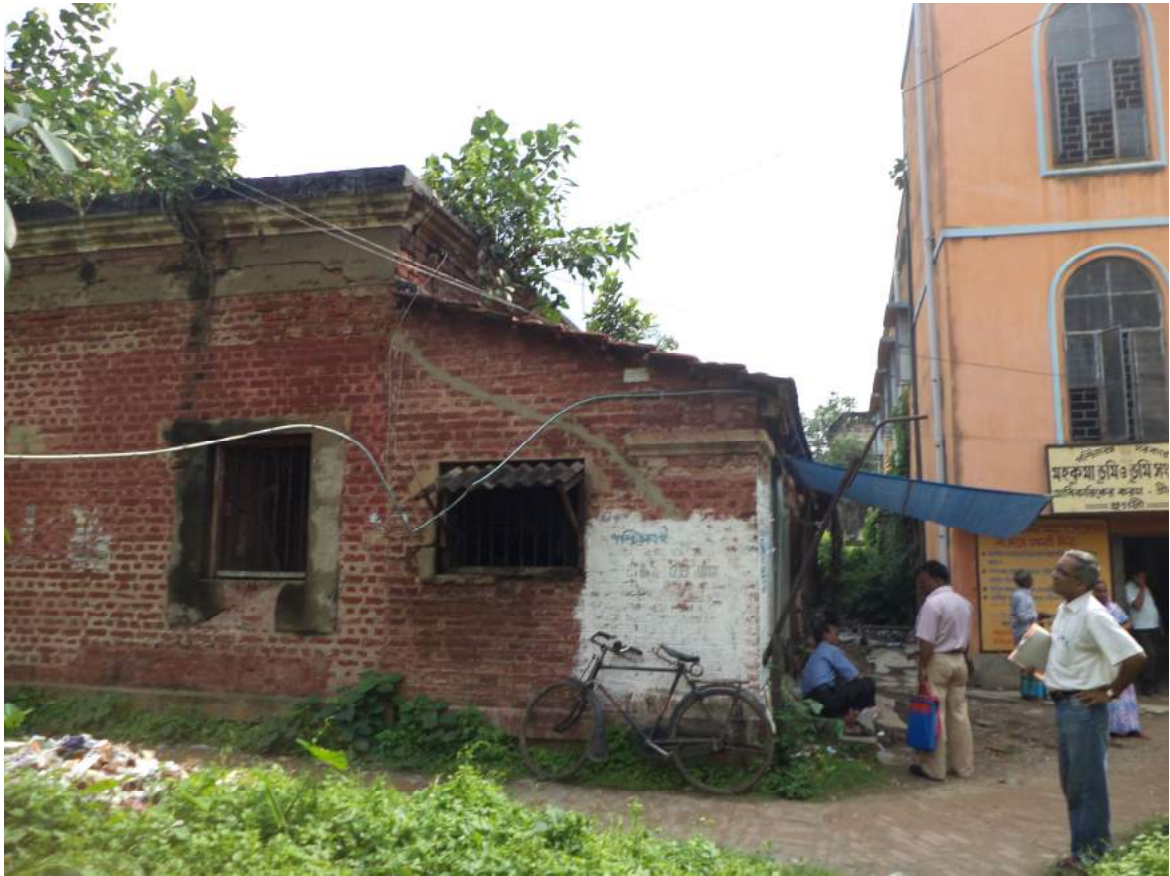
*Old BL&LRO and SDL&LRO Office, Serampore, Hooghly*

<b>Architectural and special features</b>	: Single storied brick building painted in red colour with open verandah in front and tile covered shed roof.
<b>Condition assessment</b>	: It was in a dilapidated condition with severe cracks in roofs and wall during the survey in 2013. At present it is under restoration.
<b>Statement of conservation significance</b>	: European influenced traditional bungalow typology contributing to the historicity and pleasing visual order of the Government Compound.
<b>Grade</b>	: IIA

*View of the dilapidated building with the flanking new SDL&LRO Office (2013)*

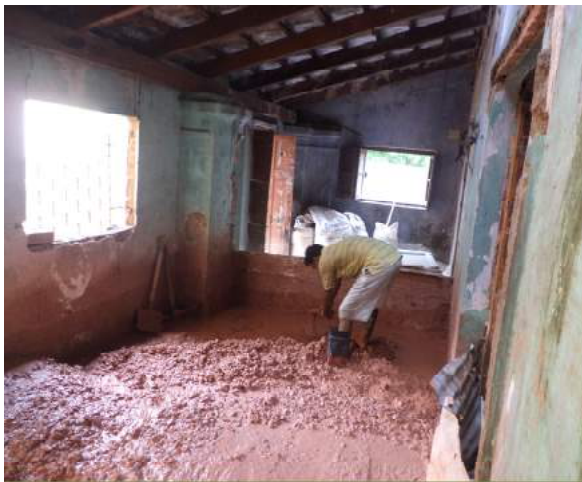
*On-going restoration works in 2016*

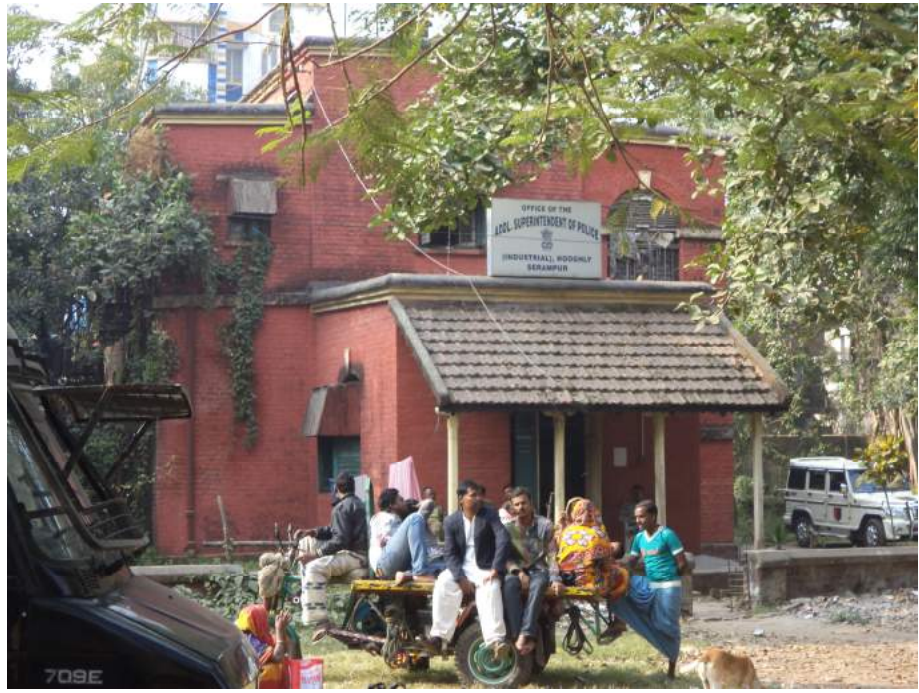
***The Office of the Additional Superintendent of Police, Industrial, Hooghly***

<b><i>Architectural and special features</i></b>	: Two storied brick building with an open porch in front with masonry pier and semi-circular arches. Exterior rendered with red stucco. Impost moulding, key stone and belt courses emphasized by yellow colour
<b><i>Condition assessment</i></b>	: Fairly good condition. Need for regular maintenance of the building with its surroundings
<b><i>Statement of conservation significance</i></b>	: European influenced traditional bungalow typology contributing to the historicity and pleasing visual order of the Government Compound
<b><i>Grade</i></b>	: IIA

*View of the entrance*

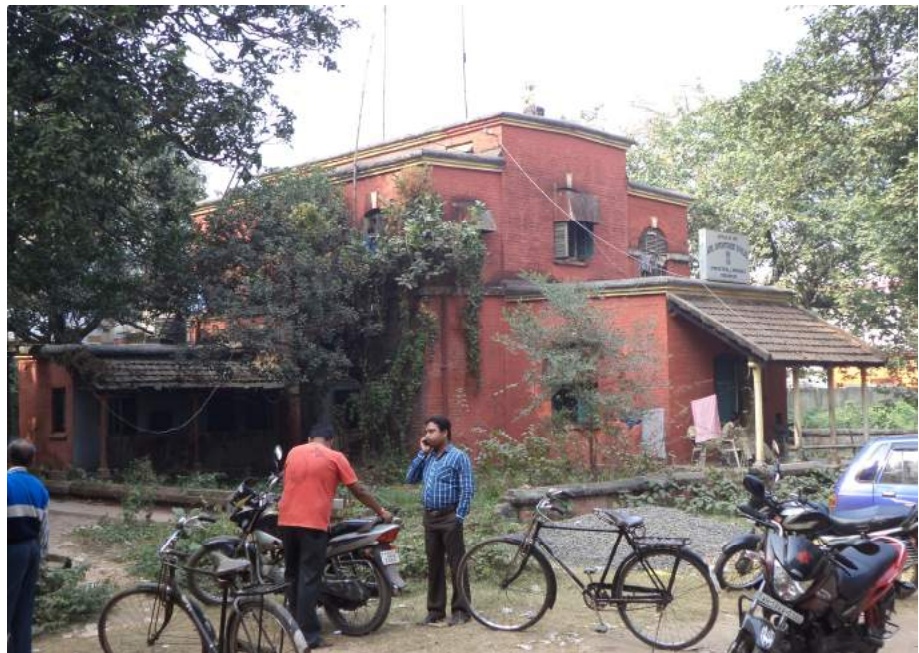
*View from south-west*

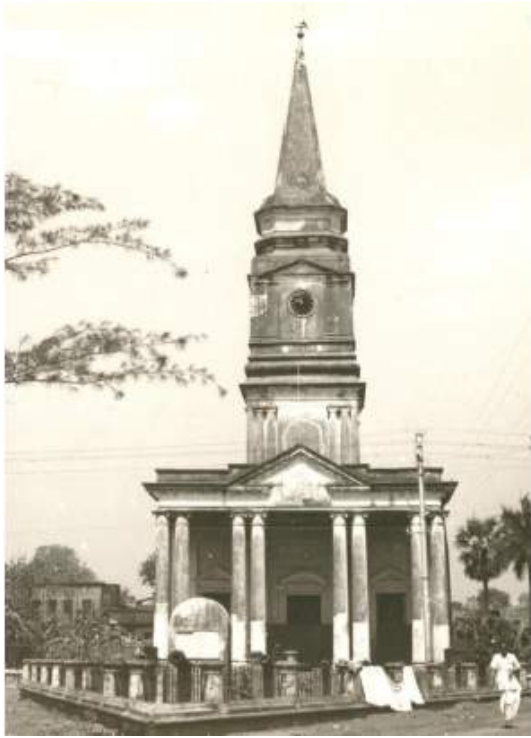
*Photograph of St. Olav's Church (in 1930s) with an open court in front forming Vista*

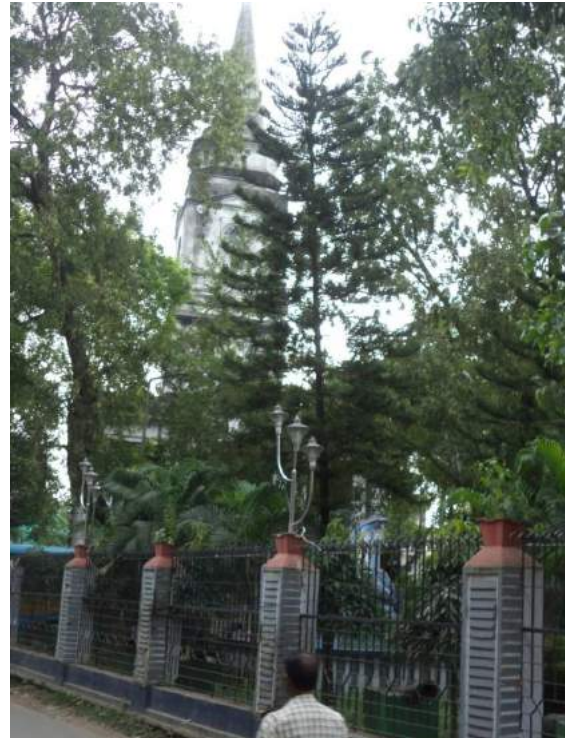
***St. Olav's Church, Serampore***

*The Church and its spire : Visually obstructed by the large trees and fence wall of the 'Dolphin Park'*

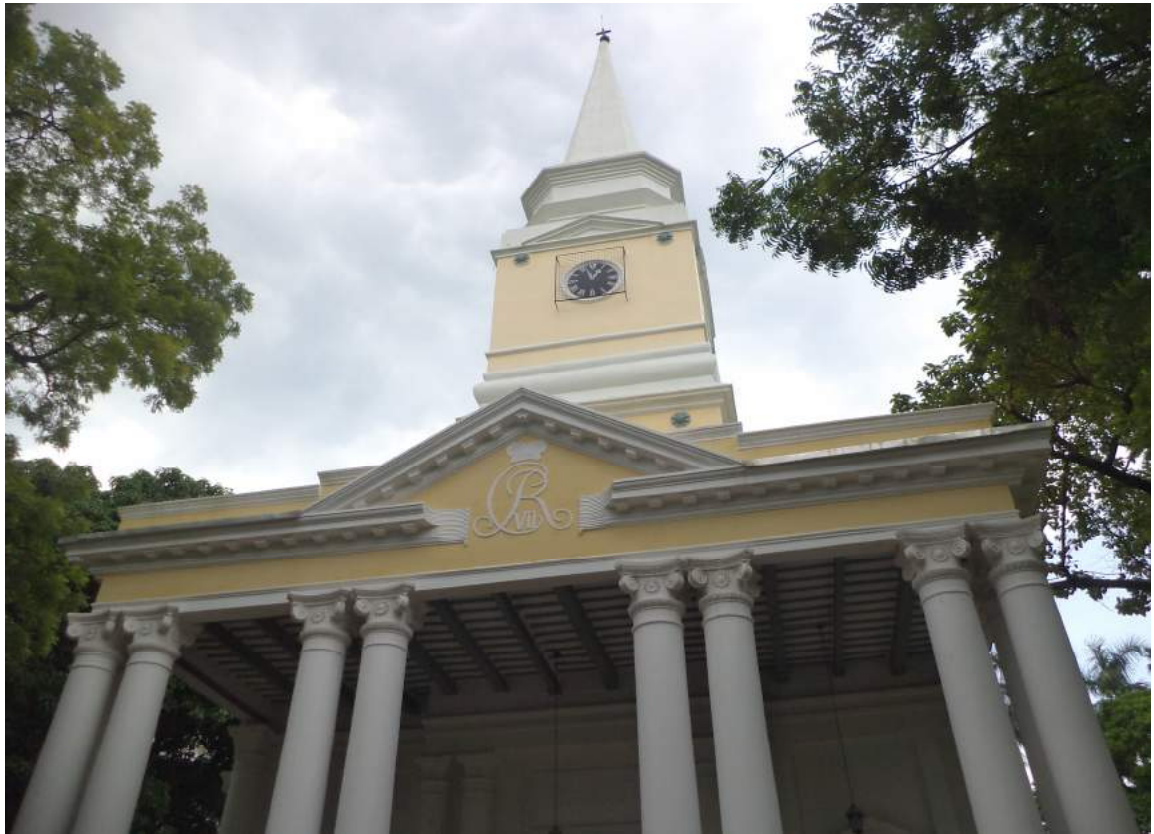
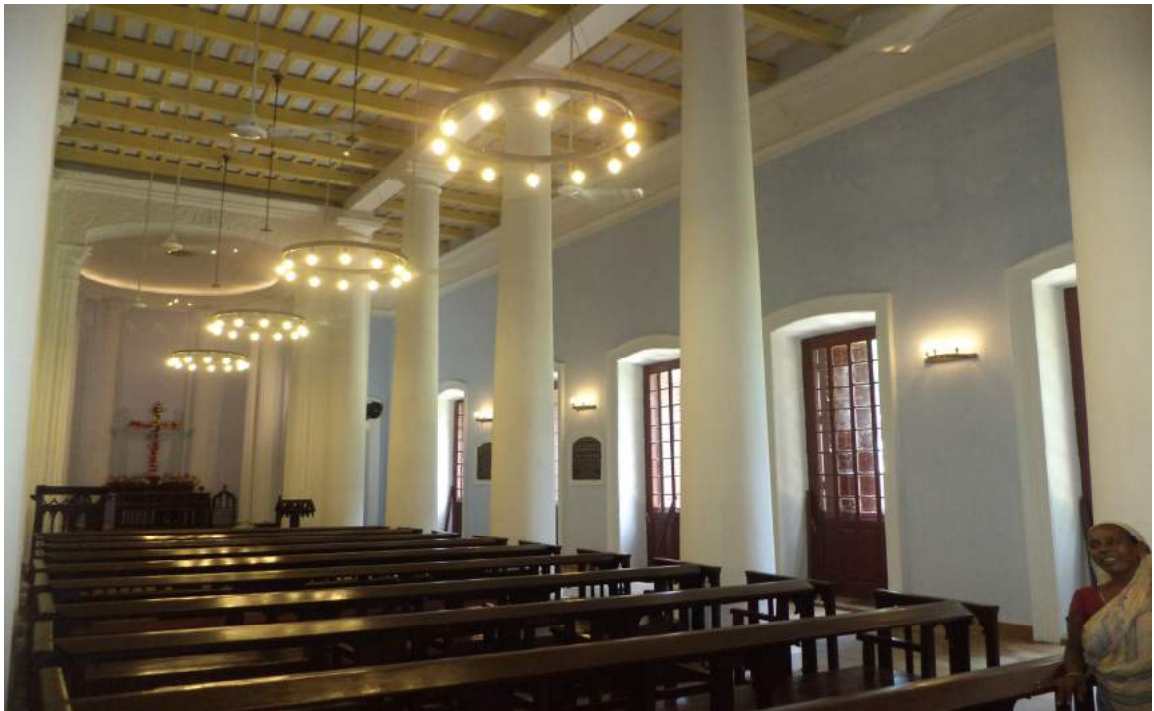
- The interior is sparsely decorated with stucco work high on the walls in the choir.
- Condition assessment** : Recently renovated and thus in a good condition. However, the building and its surroundings would require regular maintenance for the protection of its sanctity and

*St. Olav's Church, Serampore (after restoration 2016)*

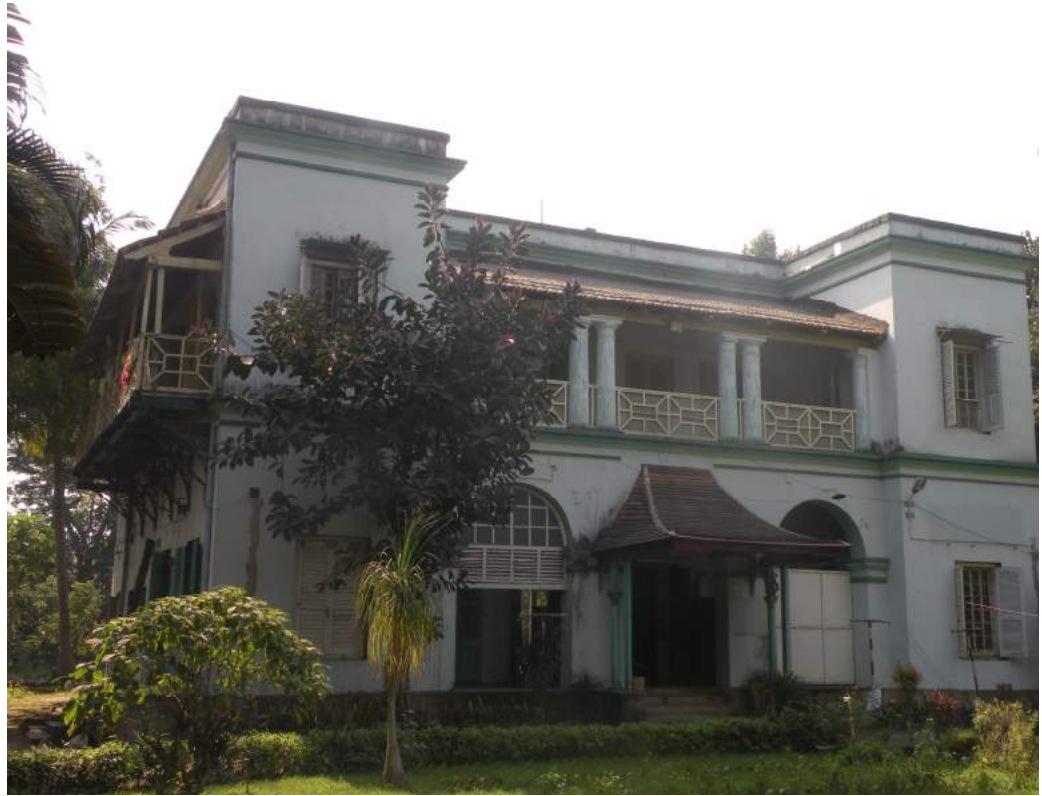
***SDO Bungalow***

<b><i>Address of the House</i></b>	:	Mahatma Gandhi Road ( Upper Strand Road), Serampore
<b><i>Name of the Owner(s)</i></b>	:	District Magistrate, Hooghly
<b><i>Contact Address</i></b>	:	Mahatma Gandhi Road, Serampore
<b><i>Description of typology</i></b>	:	European influenced traditional bungalow typology
<b><i>Year of construction / age</i></b>	:	About 150 years
<b><i>Associated history</i></b>	:	-
<b><i>Previous and existing utilization</i></b>	:	Residence of SDO
<b><i>Architectural and special features</i></b>	:	Two storey building with ground floor portico and front verandah facing the river Hooghly. Located in the middle of a large garden surrounded by a boundary wall.
<b><i>Condition assessment</i></b>	:	Fairly good condition. Dampness in brickwork of ground floor and part of the roof. Minor cracks in walls. Poor upkeep of the garden and open space adjacent to it. Some additions and alterations not in conformity with the original style of architecture. Need for regular maintenance of the buildings and its surroundings.

*View from  
North East*

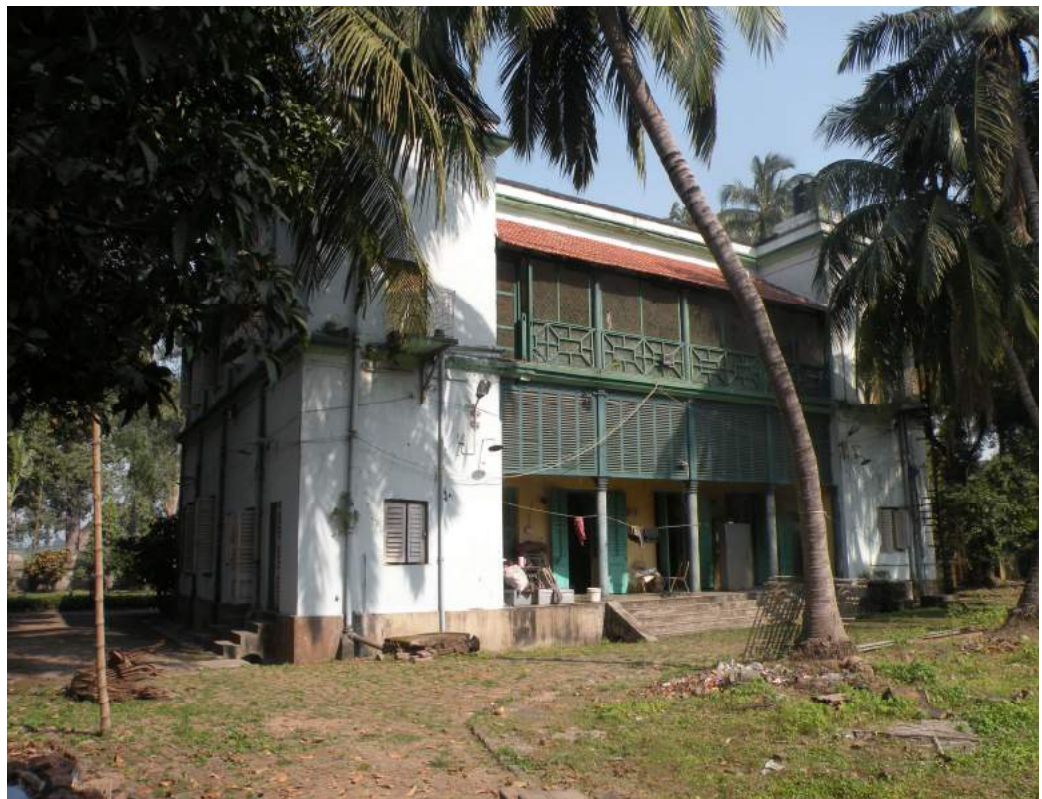
*View from  
North West*

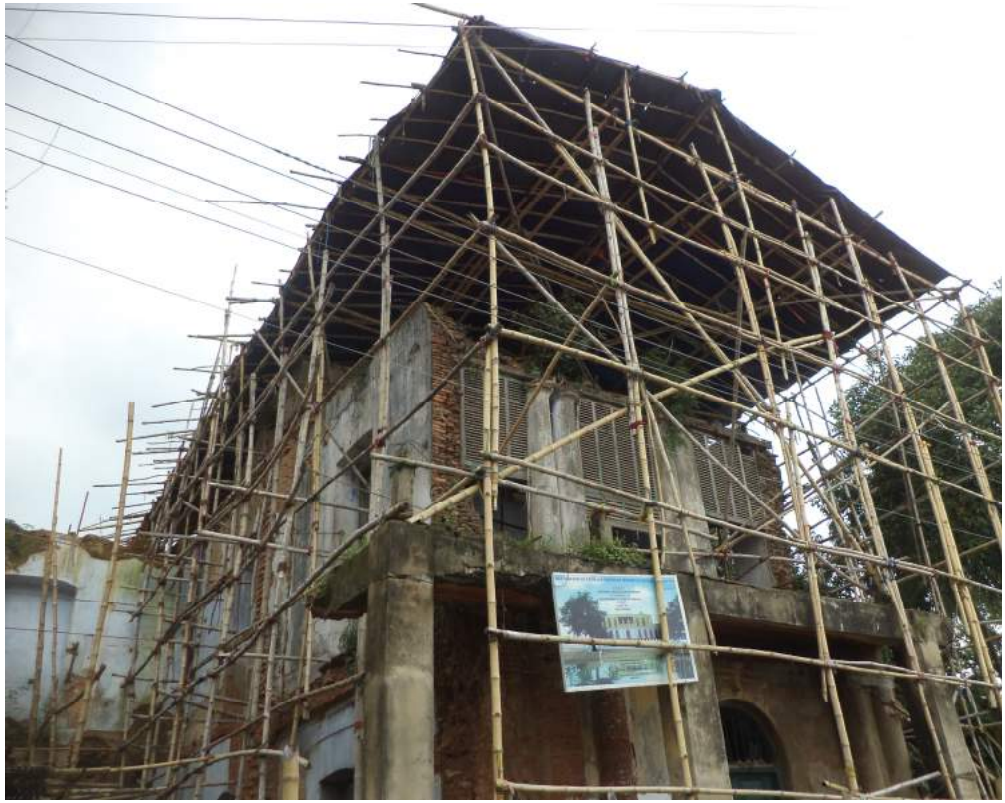
- Condition assessment** : The building is in ruined condition.
- Statement of conservation significance** : The building is one of the finest examples of 18th century European riverfront building. As it appears from the drawing of Peter Anker 1790, its northern part was built in two stories with an open portico facing the river. The villa contributes to the historicity and pleasing visual order of the river front.

*View from the river side*

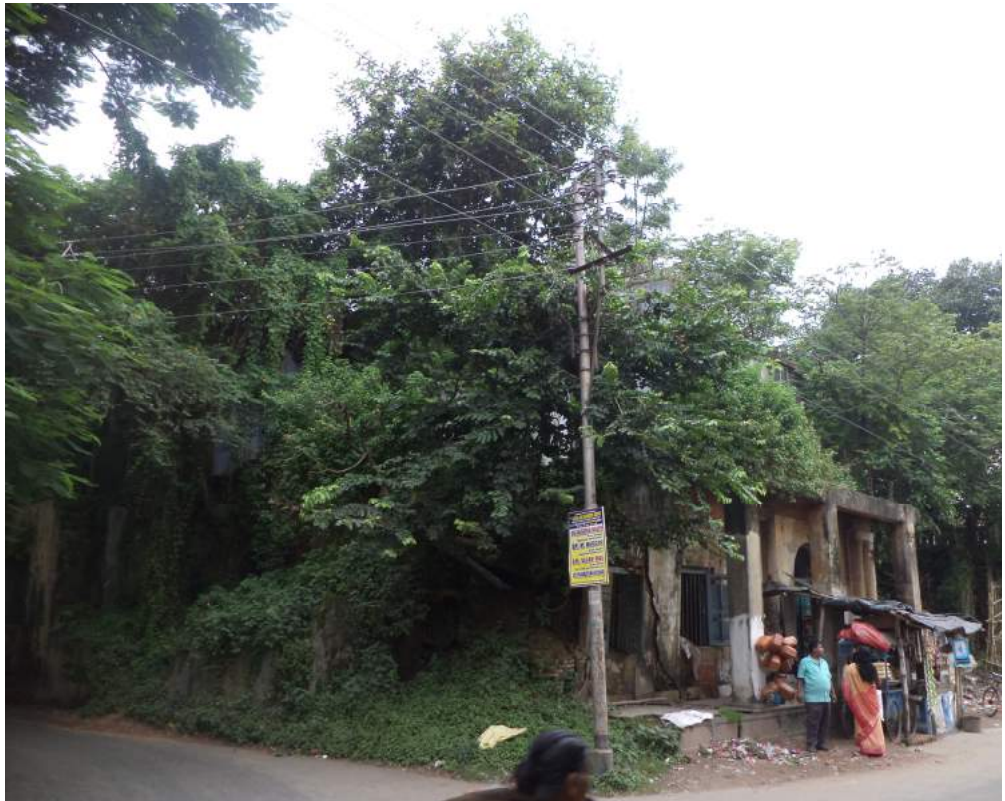
**Denmark Tavern**

*View from the river side before commencement of restoration work*

- It is presently in the process of restoration undertaken by National Museum of Denmark.
- Grade** : IIA

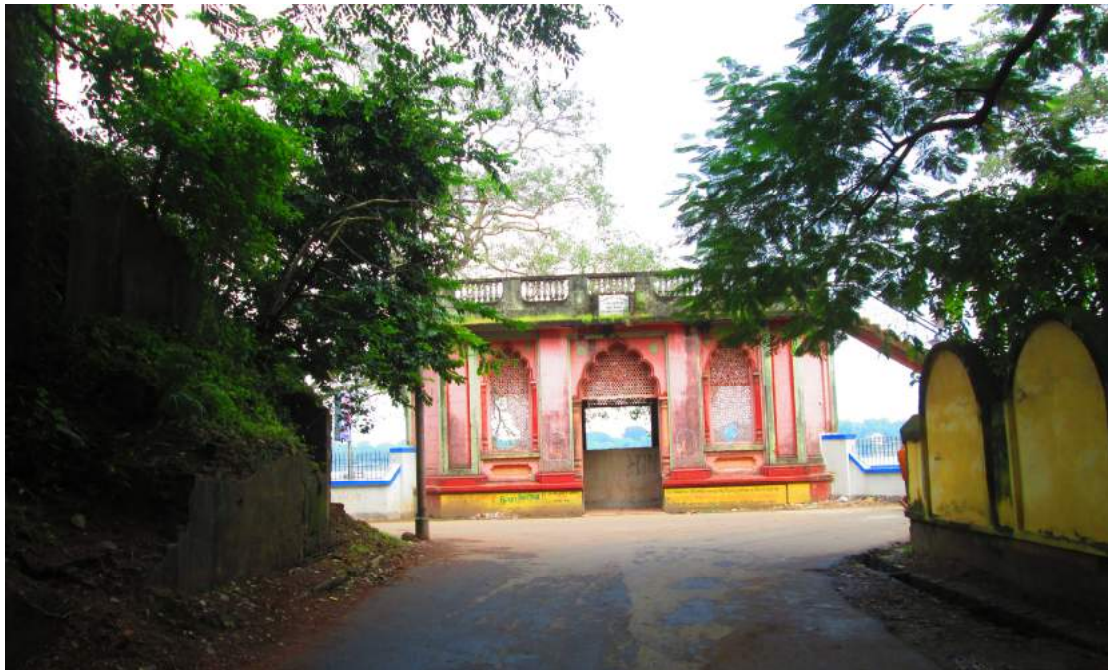
<b>Condition assessment</b>	: Fairly good condition.
<b>Statement of conservation significance</b>	: The place and its use have historical significance. However, the present structure does not have architectural significance.
<b>Grade</b>	: III

*Nishan Ghat (View from West)*

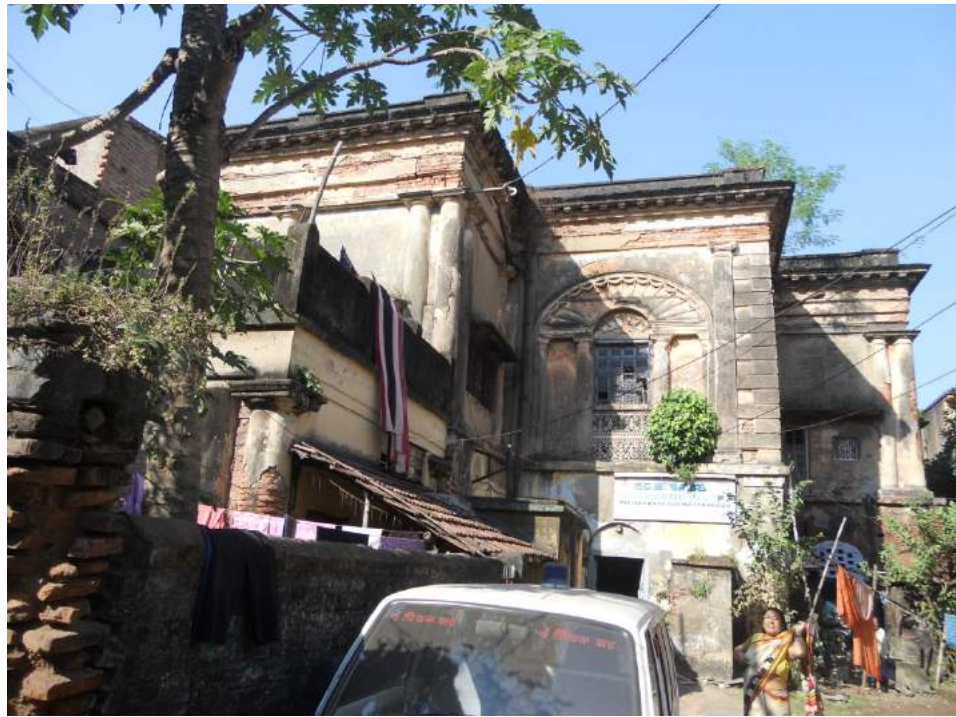
*Residence of Nag family*

<b><i>Condition assessment</i></b>	: Dilapidated condition of the porch. Building is not maintained. Additions and alterations obscuring the historic identity and architectural character.
<b><i>Statement of conservation significance</i></b>	: A classic example of European influenced bungalow typology contributing to the historicity and pleasing visual order from the street and riverside.
<b><i>Grade</i></b>	: IIB

*Southern side  
view*

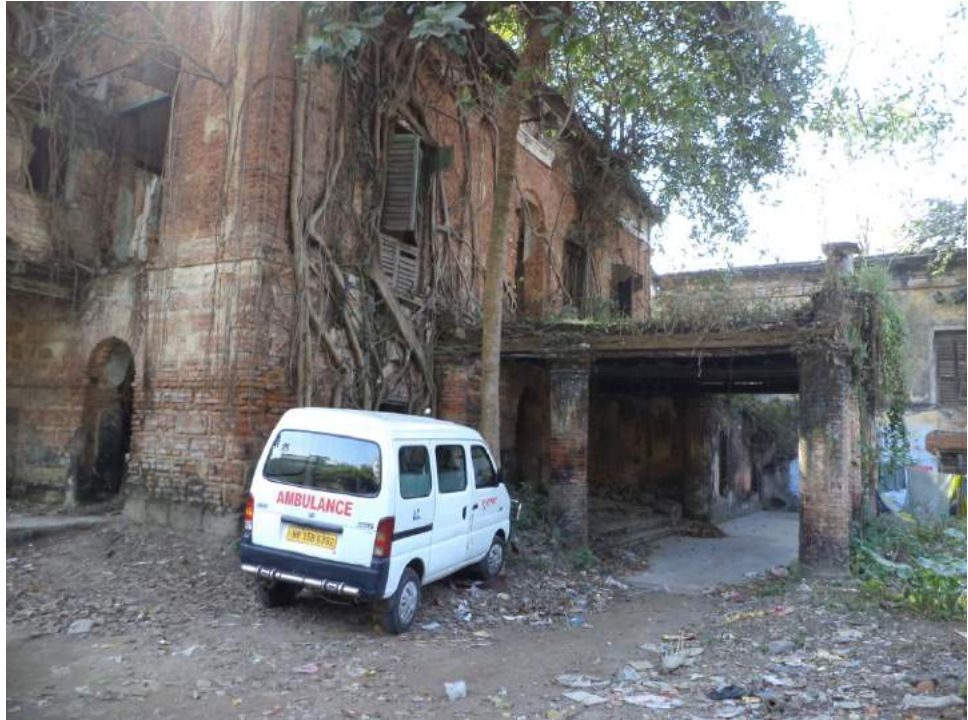
***Residence of Bose Family 1***

<b><i>Condition assessment</i></b>	: The building is in completely dilapidated condition.
<b><i>Statement of conservation significance</i></b>	: A finest example of stately building with lofty proportion. The classic example of European villa typology contributing to the historicity, and pleasing visual order of the street.
<b><i>Grade</i></b>	: IIB

*View from  
entrance*

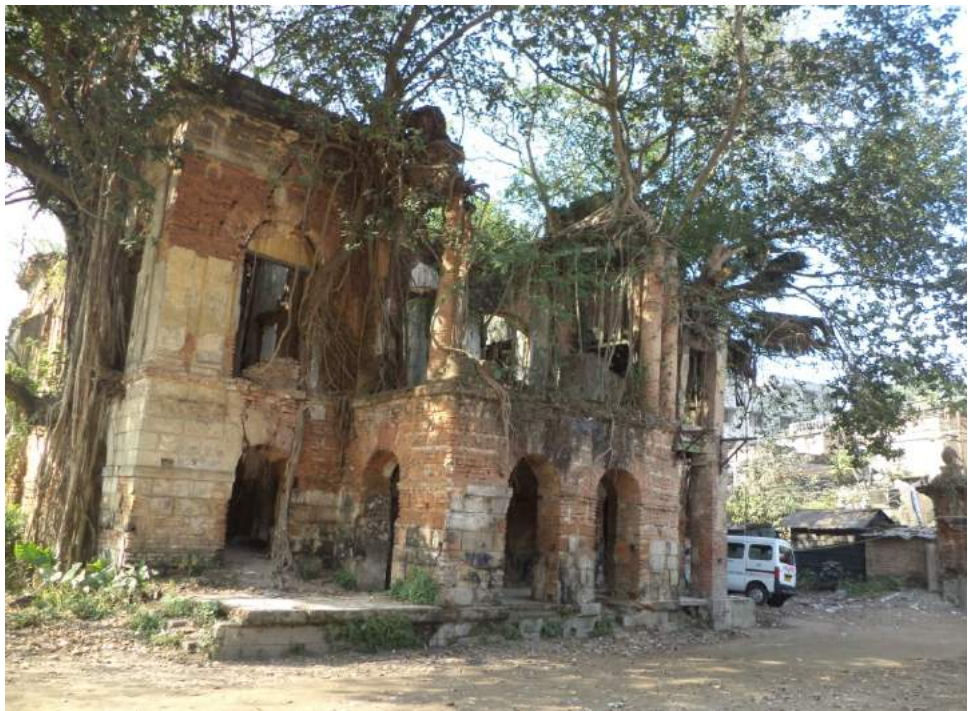
*Rear side view*

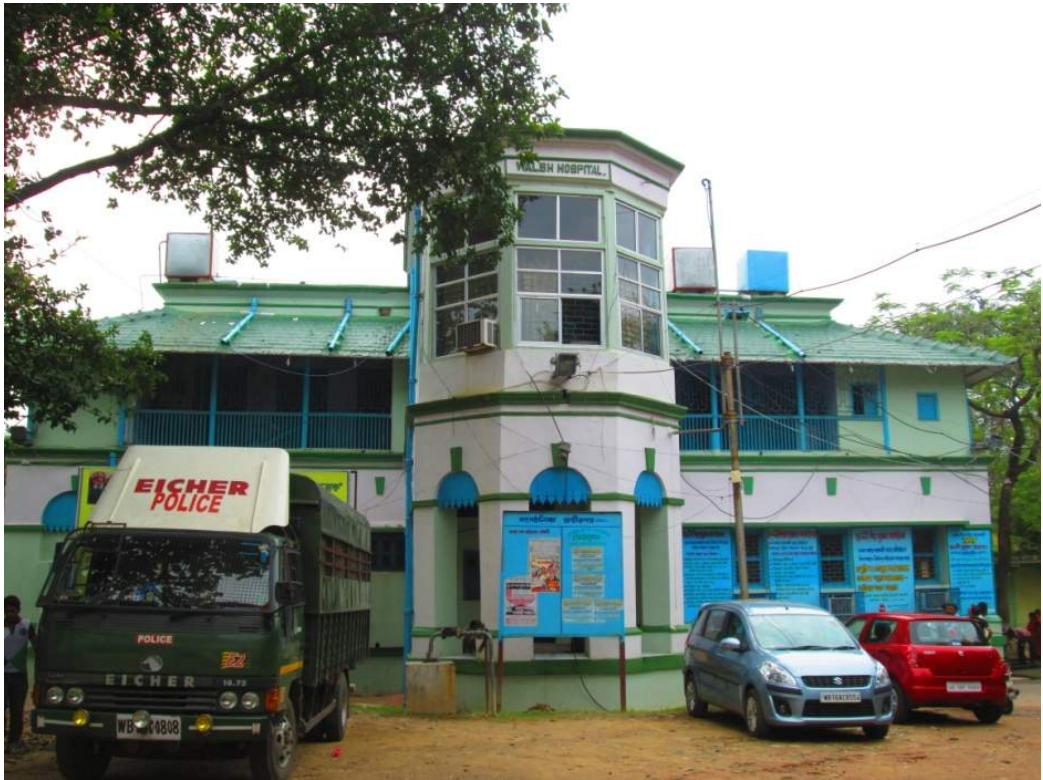
***Serampore Walsh Hospital Old Building 2***

<b><i>Condition assessment</i></b>	: Good condition. Indiscriminate display of hoardings, on-site parking and colour scheme are insensitive to the historic identity of the structure.
<b><i>Statement of conservation significance</i></b>	: The structure is one of the oldest buildings of Serampore. As a modest healthcare facility it serves thousands of common people in the town and adjacent localities.
<b><i>Grade</i></b>	: IIA

*View from entrance*

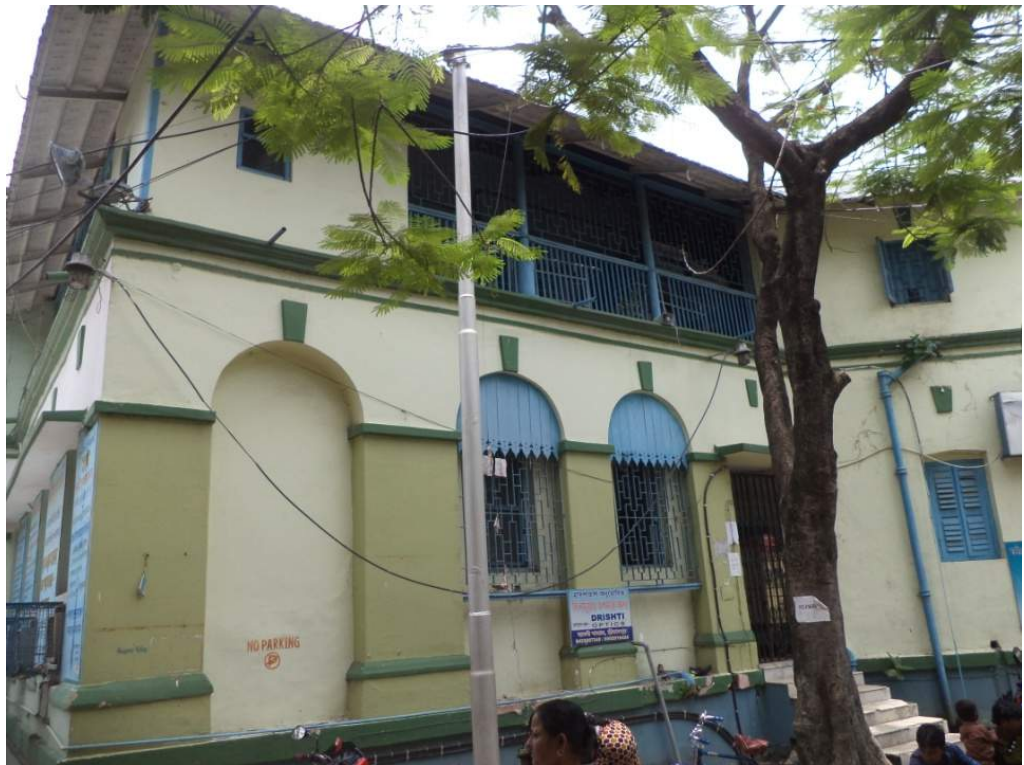
*Northern side view*
