# Listing and Assessment of Heritage Buildings in Serampore's Historic Core

Final Report

Research Consultant  
School of Ecology, Infrastructure and Human Settlement Management  
Indian Institute of Engineering Science and Technology, Shibpur, West Bengal, India

August 2016

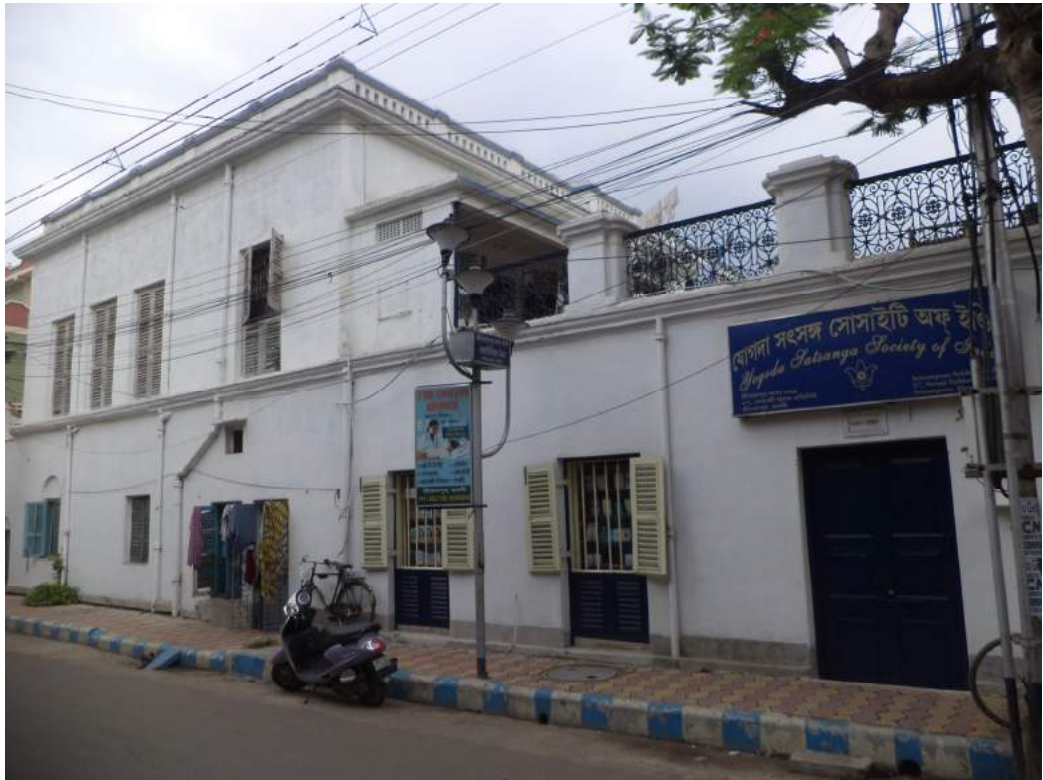
*View from  
entrance*

<b>Address</b>	: 57, Netaji Subhas Avenue (Previously known as Queen Street)
<b>Ownership</b>	: Yogoda Satsang Society of India
<b>Contact address</b>	: 57, Netaji Subhas Avenue
<b>Description of typology</b>	: European influenced traditional bungalow typology
<b>Year of construction / age</b>	: More than 150 years
<b>Associated history</b>	: House initially owned by Sarada Prasad Ghosh has been donated to Satsang Society of India.
<b>Previous and existing utilization</b>	: Previously used as residence. Presently used as office, religious centre, guest house and weekly charitable dispensary by Satsang Society of India.
<b>Architectural and special features</b>	: A courtyard house with European characteristics. Large wooden louvered windows and wooden beams supporting the tile roof with lime terracing.
<b>Condition assessment</b>	: Good condition and well maintained.
<b>Statement of conservation significance</b>	: A classic example of European influenced traditional bungalow typology contributing to the historicity and pleasing visual order of Netaji Subhas Avenue (previously known as Queen Street). Cultural and religious activities contributing to community life of Serampore.

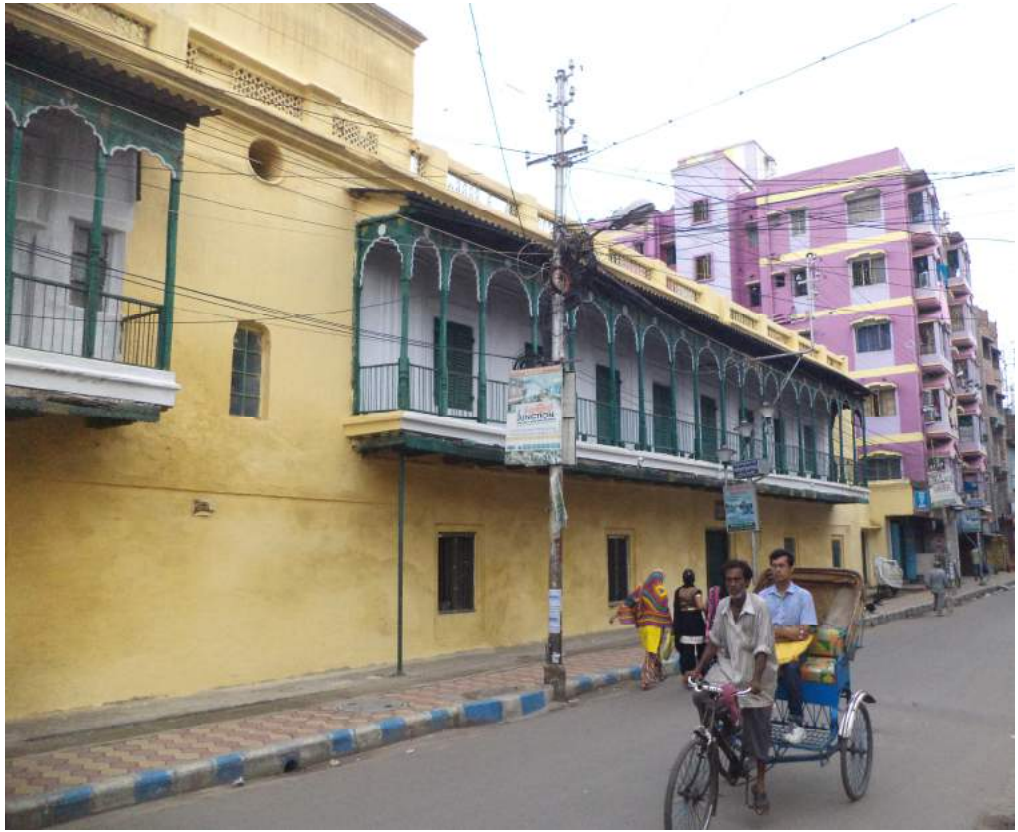
*View from  
entrance*

<b>Address</b>	: 53 Netaji Subhas Avenue (Previously known as Queen Street)
<b>Ownership</b>	: Sunil Kr. Roy and three others
<b>Contact address</b>	: 53 Netaji Subhas Avenue
<b>Description of typology</b>	: European influenced traditional courtyard centric bungalow typology.
<b>Year of construction / age</b>	: 280-300 years old
<b>Associated history</b>	: Home of 14th generation of Roy family. The family is a descendent of Madhai who was a close aid of social reformer Sri Chaitanya Dev.
<b>Previous and existing utilization</b>	: Residence
<b>Architectural and special features</b>	: Columns of Ionic Style, brackets, motifs, louvers, cornice and frieze, large vertical wooden windows. Two courtyards represent the public and private spheres of residential function of the landed gentry of Serampore.
<b>Condition assessment</b>	: Good condition of structure with few signs of dampness on walls.
<b>Statement of conservation significance</b>	: Very strong conservation significance as the building and the family have close association with the cultural life of Serampore for their tradition in holding classical music conferences.

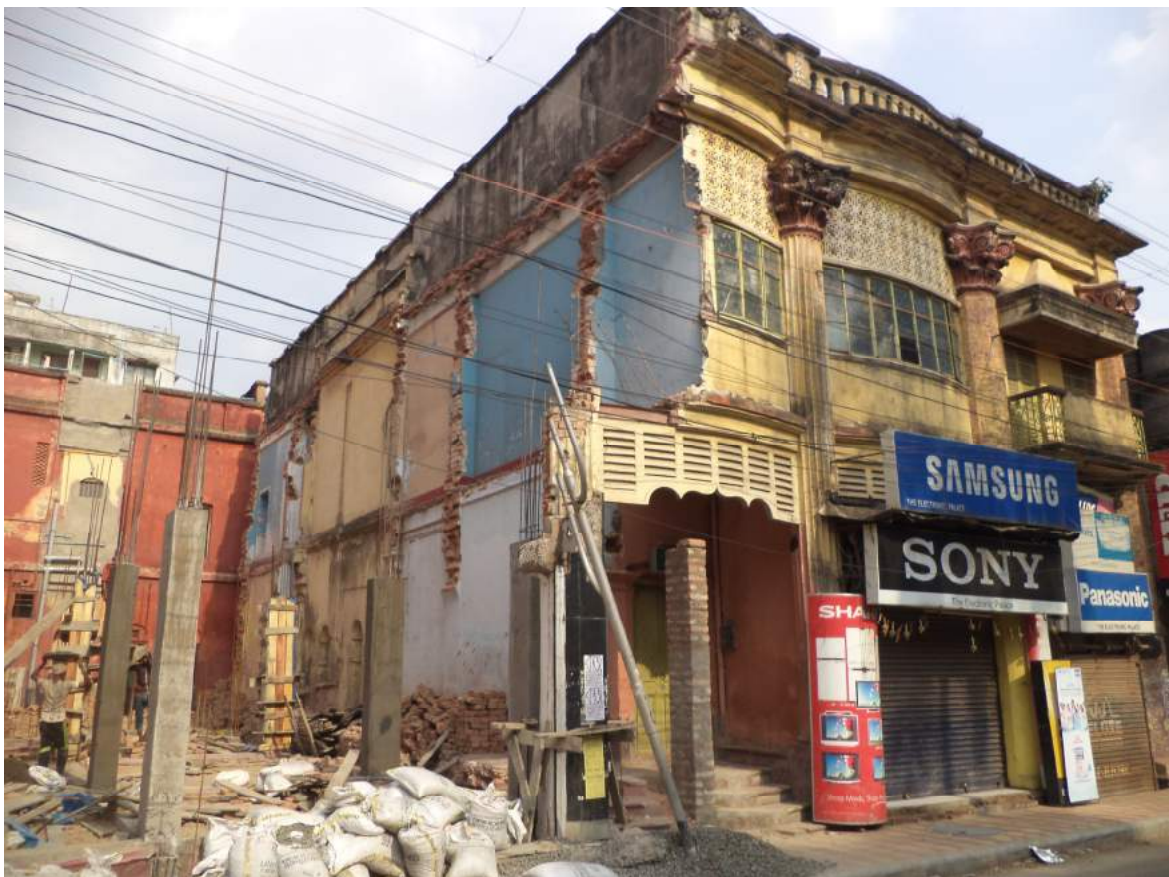
*Residence of Sarkar Family*

<b>Address of the Heritage</b>	:	50, N.S. Avenue (Queen Street)
<b>Name of the Owner(s)</b>	:	Pritam Sarkar and others
<b>Contact Address</b>	:	50, N.S. Avenue (Queen Street)
<b>Description of typology</b>	:	European influenced traditional bungalow typology
<b>Year of construction / age</b>	:	About 200 years
<b>Associated history</b>	:	-
<b>Previous and existing utilization</b>	:	Pavilion overlooking the river
<b>Architectural and special features</b>	:	Corinthian column is the dominant feature of the facade.
<b>Condition assessment</b>	:	The building is in good condition. However a part of it is demolished for real estate development
<b>Statement of conservation significance</b>	:	Long facade of European influenced traditional bungalow typology contributing to the historicity and pleasing visual order of N.S. Avenue
<b>Grade</b>	:	IIB

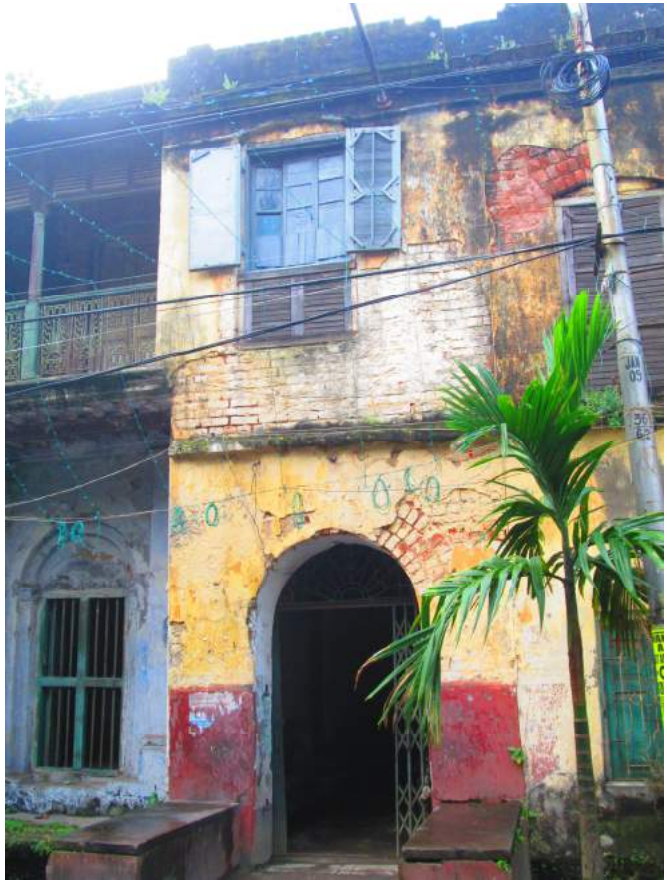
*Residence of Khetra Mohan Sha*

<b>Condition assessment</b>	: Very poor maintenance and part of the building in dilapidated condition.
<b>Statement of conservation significance</b>	: Very strong conservation significance as the building and the family contributed significantly to the socio-political and cultural life of Serampore. Multi-courtyard building typology represents the climate responsive residential architecture and public-private sphere of the culture of joint family living in Bengal.
<b>Grade</b>	: IIA

*View from entrance*

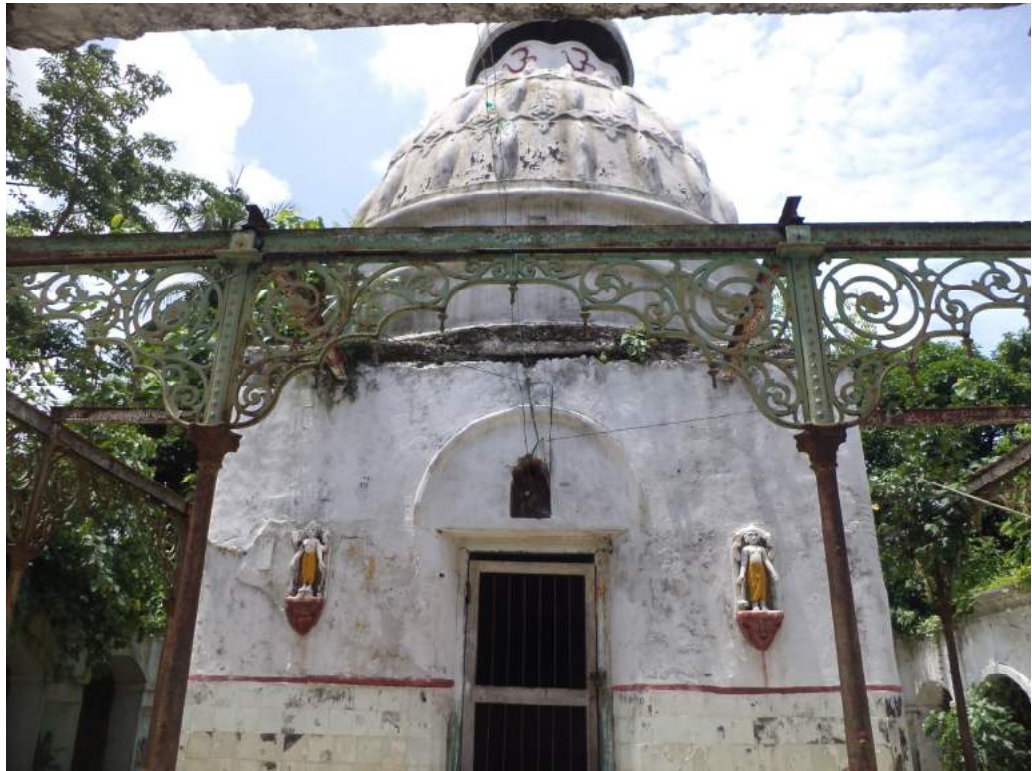
***Temple Complex and fairground of Khetra Mohan Sha***

<b>Architectural and special features</b>	: A very large integrated building complex unified by a water body and courtyards.
<b>Condition assessment</b>	: Very poor maintenance and part of the building is in dilapidated condition. Only the temple complex is maintained.
<b>Statement of conservation significance</b>	: Very strong conservation significance as the building and the family contributed significantly to the socio-political and cultural life of Serampore. Large water body merits attention from environmental consideration.
<b>Grade</b>	: IIA

*View of  
Temple*

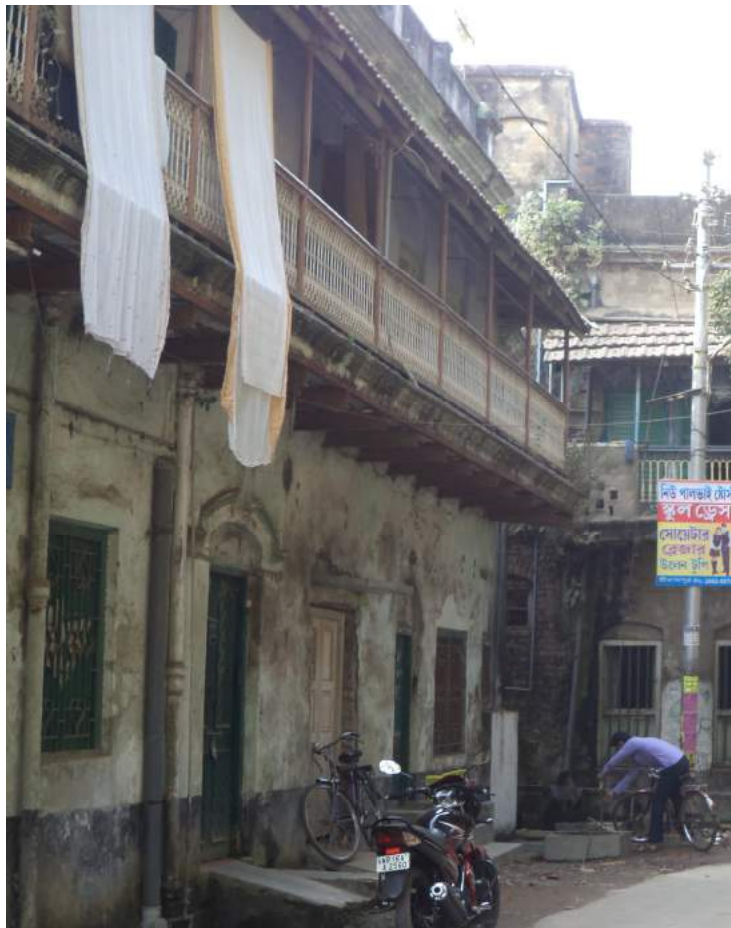
*Residence of Dey Family*

<b><i>Address of the Heritage</i></b>	: 1, Gopinath Saha Street
<b><i>Name of the Owner(s)</i></b>	: Sudip Dey and others
<b><i>Contact Address</i></b>	: 1, Gopinath Saha Street
<b><i>Description of typology</i></b>	: European influenced traditional bungalow typology
<b><i>Year of construction / age</i></b>	: About 150 years
<b><i>Associated history</i></b>	: -
<b><i>Previous and existing utilization</i></b>	: Residence
<b><i>Architectural and special features</i></b>	: Due to modification historic identity is in a state of decline. Cantilever verandah with lean to roof in first floor lends a visual order to the street.
<b><i>Condition assessment</i></b>	: Part of the building well maintained. Rest poorly maintained.
<b><i>Statement of conservation significance</i></b>	: Significant from streetscape perspective.
<b><i>Grade</i></b>	: IIB

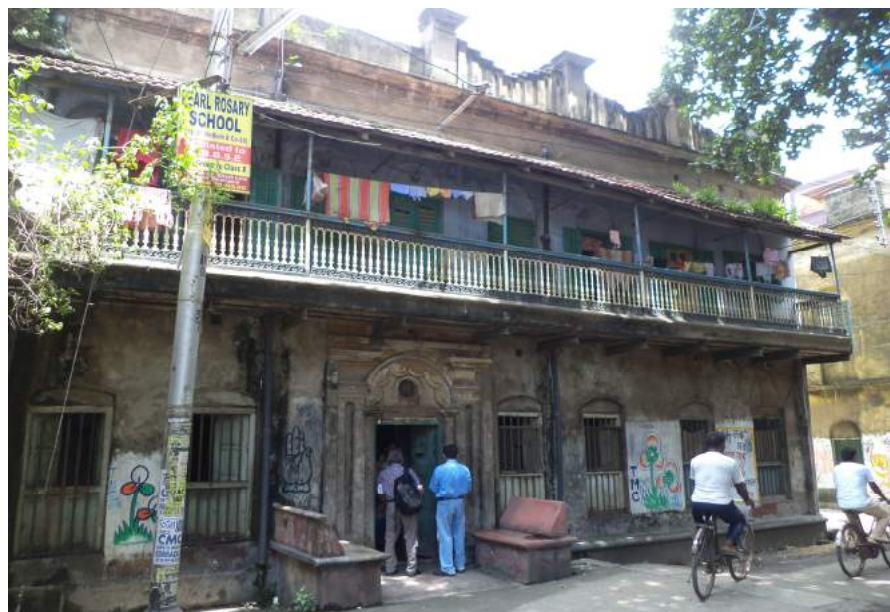
View from entrance

<b>Address</b>	: 5, Dr. B. N. Jot Sarani (Previously Church Street)
<b>Ownership</b>	: Baidyanath Das
<b>Contact address</b>	: 5, Dr. B. N. Jot Sarani (Previously Church Street)
<b>Description of typology</b>	: European influenced traditional bungalow typology
<b>Year of construction / age</b>	: More than 150 years
<b>Associated history</b>	: -
<b>Previous and existing utilization</b>	: Residence
<b>Architectural and special features</b>	: Due to modification historic identity is in a state of decline. Arched entrance door with seating platform and cantilever verandah lend a visual order to the street.
<b>Condition assessment</b>	: Part of the building well maintained. Rest poorly maintained.
<b>Statement of conservation significance</b>	: Significant from streetscape perspective.
<b>Grade</b>	: IIB

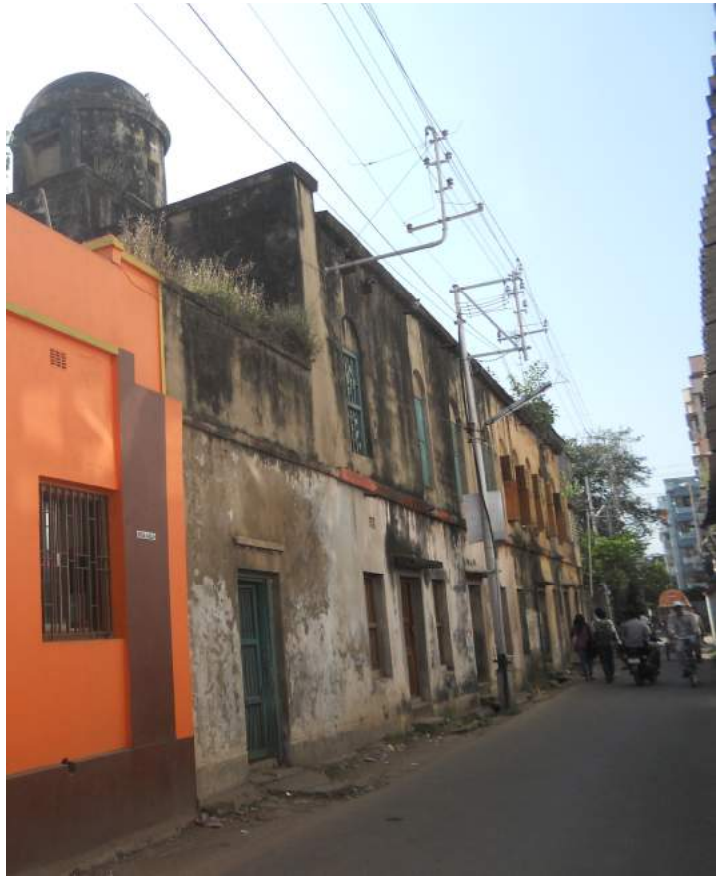
*View from entrance*

<b><i>Address</i></b>	: 34 Shibchandra Palit Lane
<b><i>Ownership</i></b>	: Tapan Chatterjee and Pradip Chatterjee
<b><i>Contact address</i></b>	: 34 Shibchandra Palit Lane
<b><i>Description of typology</i></b>	: European influenced traditional bungalow typology
<b><i>Year of construction / age</i></b>	: More than 200 years
<b><i>Associated history</i></b>	: -
<b><i>Previous and existing utilization</i></b>	: Residence
<b><i>Architectural and special features</i></b>	: A two storied courtyard house and wooden beams supported tile roof with lime terracing. Brick cupola over the staircase.
<b><i>Condition assessment</i></b>	: Poor maintenance and dilapidated condition.
<b><i>Statement of conservation significance</i></b>	: Significant from streetscape perspective.
<b><i>Grade</i></b>	: IIB

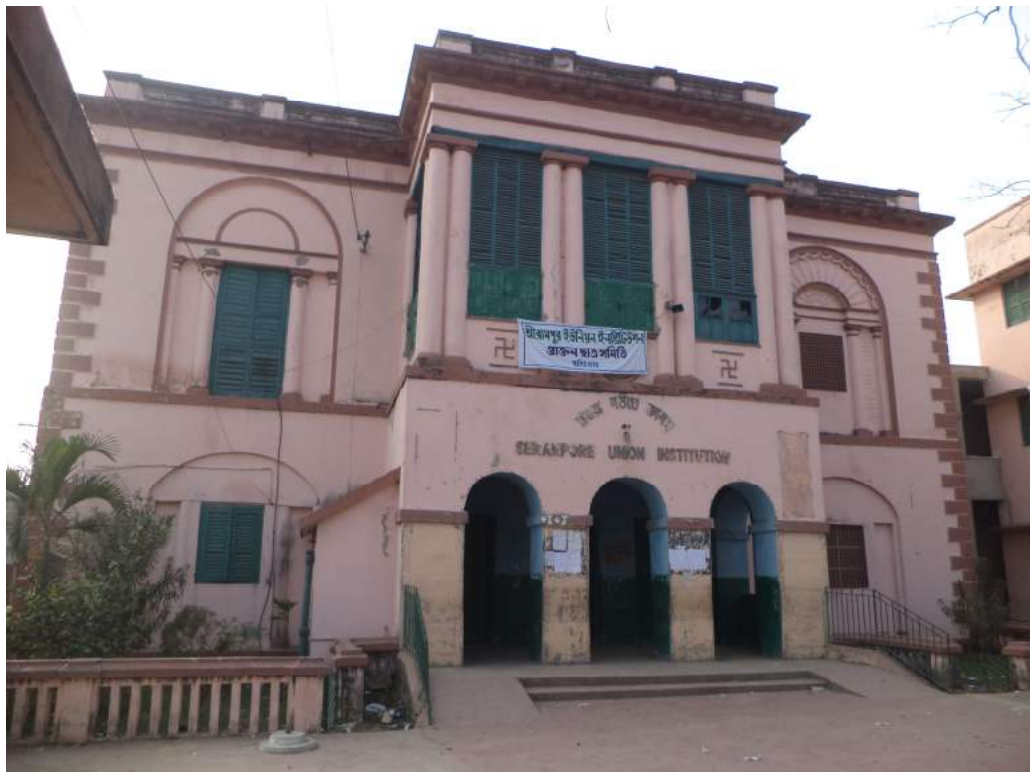
*Serampore Union High School old building*

<b>Address of the Heritage</b>	: 7, K.M. Bhattacharya Street
<b>Name of the Owner(s)</b>	: Education Department, Govt. of West Bengal
<b>Contact Address</b>	: 7, K.M. Bhattacharya Street
<b>Description of typology</b>	: European villa typology
<b>Year of construction / age</b>	: About 150 years
<b>Associated history</b>	: -
<b>Previous and existing utilization</b>	: High School
<b>Architectural and special features</b>	: Two storey building with ground floor portico with semicircular arch and Doric columns and opening treated with venetian louvers.
<b>Condition assessment</b>	: Good condition and well maintained
<b>Statement of conservation significance</b>	: One of the finest examples of European villa typology with climate sensitive venetian louvers appropriate to warm humid condition.
<b>Grade</b>	: IIA

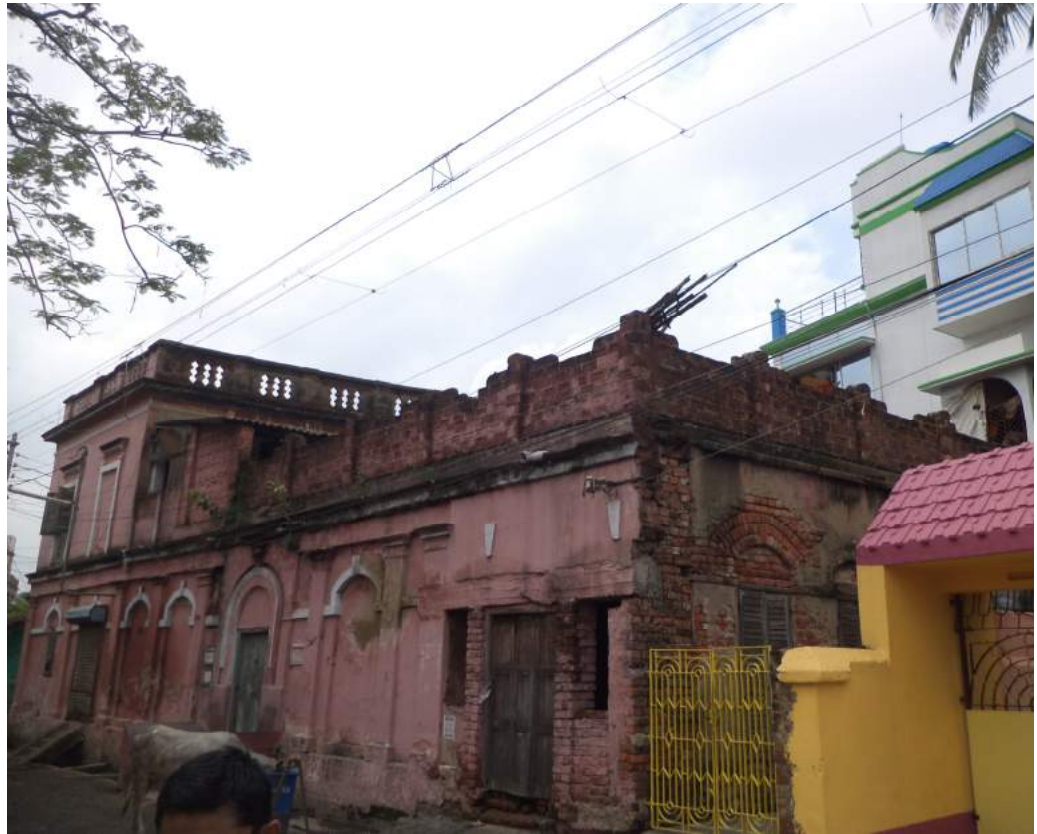
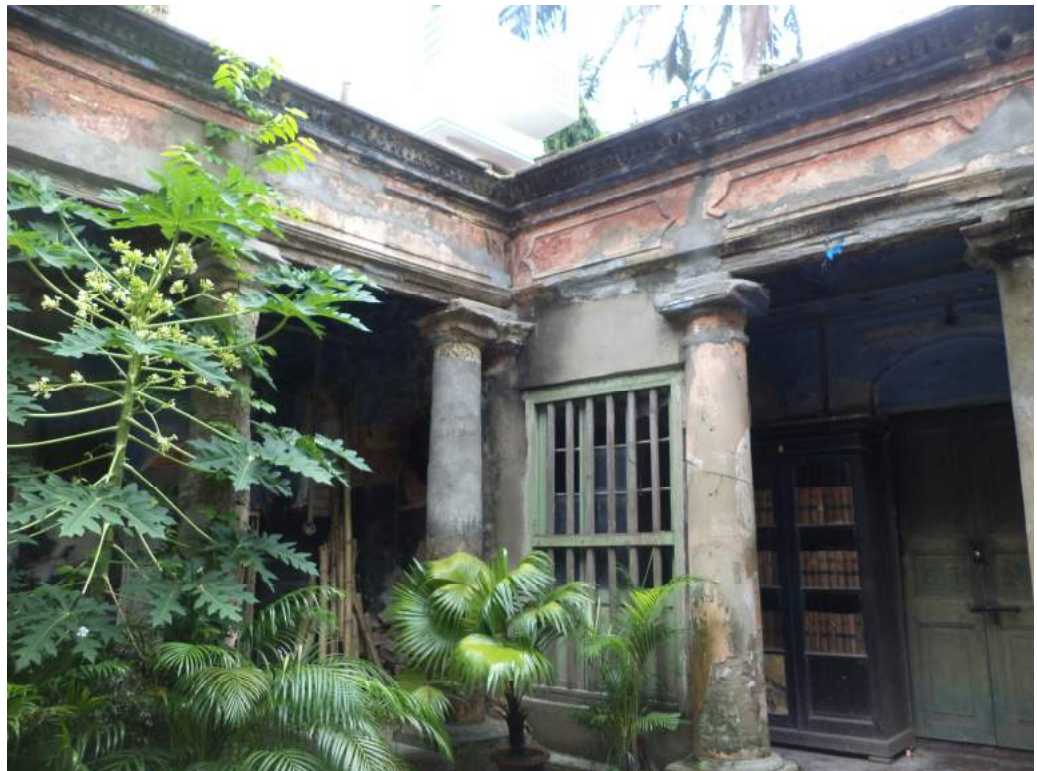
***Haranath Bhavan***

<b><i>Address</i></b>	: 54, K.M. Bhattacharya Street
<b><i>Ownership</i></b>	: Kanandeb Bhattacharya and two others
<b><i>Contact address</i></b>	: 54, K.M. Bhattacharya Street
<b><i>Description of typology</i></b>	: European influenced traditional bungalow typology
<b><i>Year of construction / age</i></b>	: 1884
<b><i>Associated history</i></b>	: Built by Haranath Bhattacharya in 1884.
<b><i>Previous and existing utilization</i></b>	: The building is being used primarily for residential purpose. Few years ago a portion of the house was utilized for silk screen printing.
<b><i>Architectural and special features</i></b>	: Flat roof (tiles with lime terracing as water proofing) supported on wooden beams. Few rooms have Italian marble flooring and verandah (balcony) fitted with wooden louvered screens. Hanging glass lanterns (shamadan) observed in some of the rooms.
<b><i>Condition assessment</i></b>	: Poor maintenance with dampness observed in walls and roofs.

<b><i>Statement of conservation significance</i></b>	: Significant architectural typology and historic interior decor with climate responsive wooden louvers screening the verandah (balcony) from the open courtyard.
<b><i>Grade</i></b>	: IIA

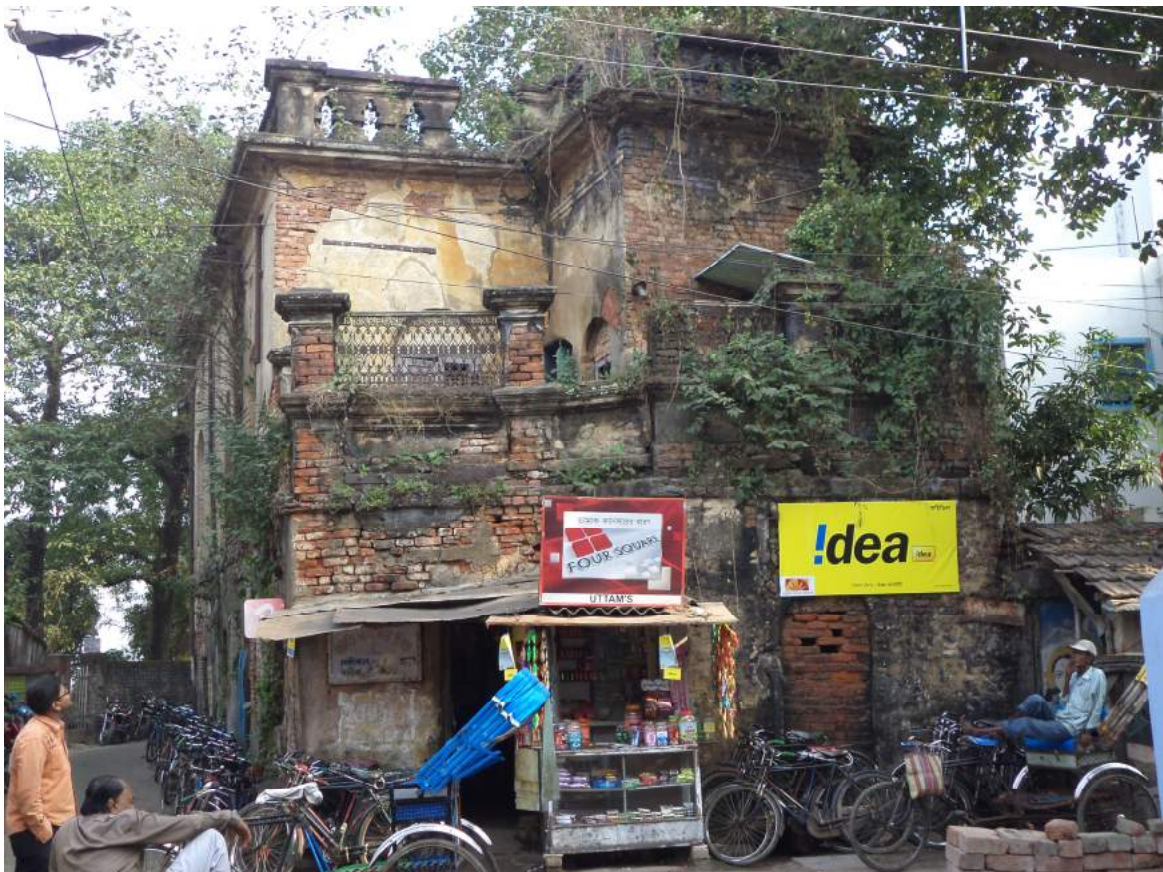
*State Bank of India Old Building*

<b>Address of the Heritage</b>	: 58, N.N. Roy Street
<b>Name of the Owner(s)</b>	: State Bank of India
<b>Contact Address</b>	: 58, N.N. Roy Street
<b>Description of typology</b>	: European villa typology
<b>Year of construction / age</b>	: About 200 years
<b>Associated history</b>	: -
<b>Previous and existing utilization</b>	: Occupied by State Bank of India. Abandoned at present.
<b>Architectural and special features</b>	: Parts of the structure built with lakhori bricks indicating its construction period during 18 <sup>th</sup> century.
<b>Condition assessment</b>	: The building is in ruined condition. Declared as unsafe.
<b>Statement of conservation significance</b>	: The villa contributes to the historicity and pleasing visual order of the riverfront.
<b>Grade</b>	: IIB

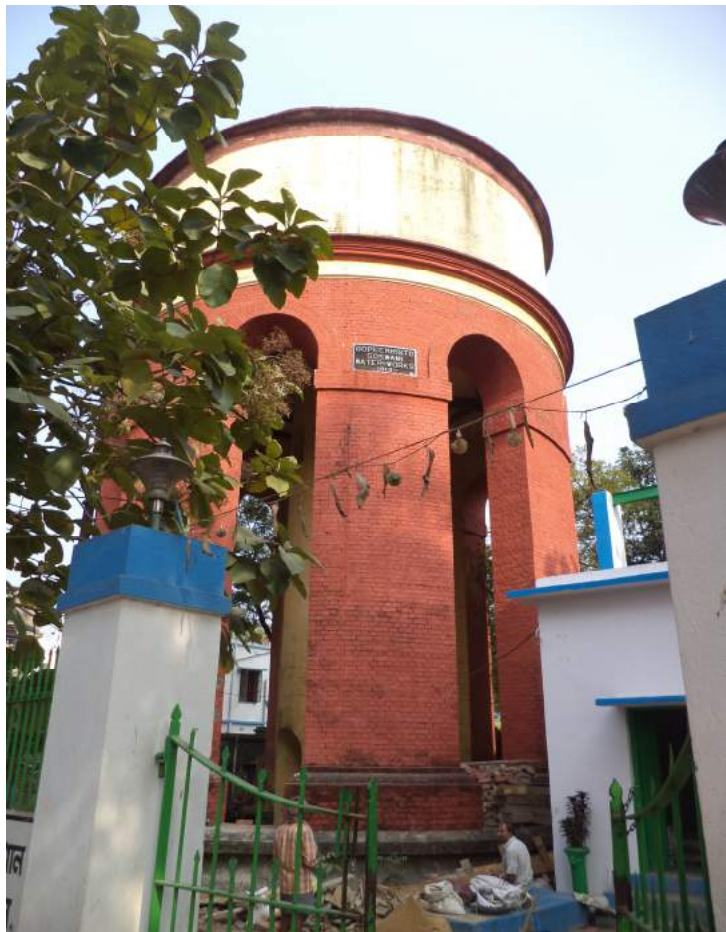
***Water Tower***

<b><i>Address of the Heritage</i></b>	: N.N. Roy Street
<b><i>Name of the Owner(s)</i></b>	: Serampore Municipality
<b><i>Contact Address</i></b>	: N.N. Roy Street
<b><i>Description of typology</i></b>	: Municipal infrastructure
<b><i>Year of construction / age</i></b>	: 1903
<b><i>Associated history</i></b>	: -
<b><i>Previous and existing utilization</i></b>	: Municipal water works
<b><i>Architectural and special features</i></b>	: Exposed brick structure with semicircular arches.
<b><i>Condition assessment</i></b>	: The structure is in good condition.
<b><i>Statement of conservation significance</i></b>	: Very significant landmark. It represents a visible testimony to the early stage of development of municipal infrastructure for the improvement of living conditions of citizens in Serampore.
<b><i>Grade</i></b>	: IIA

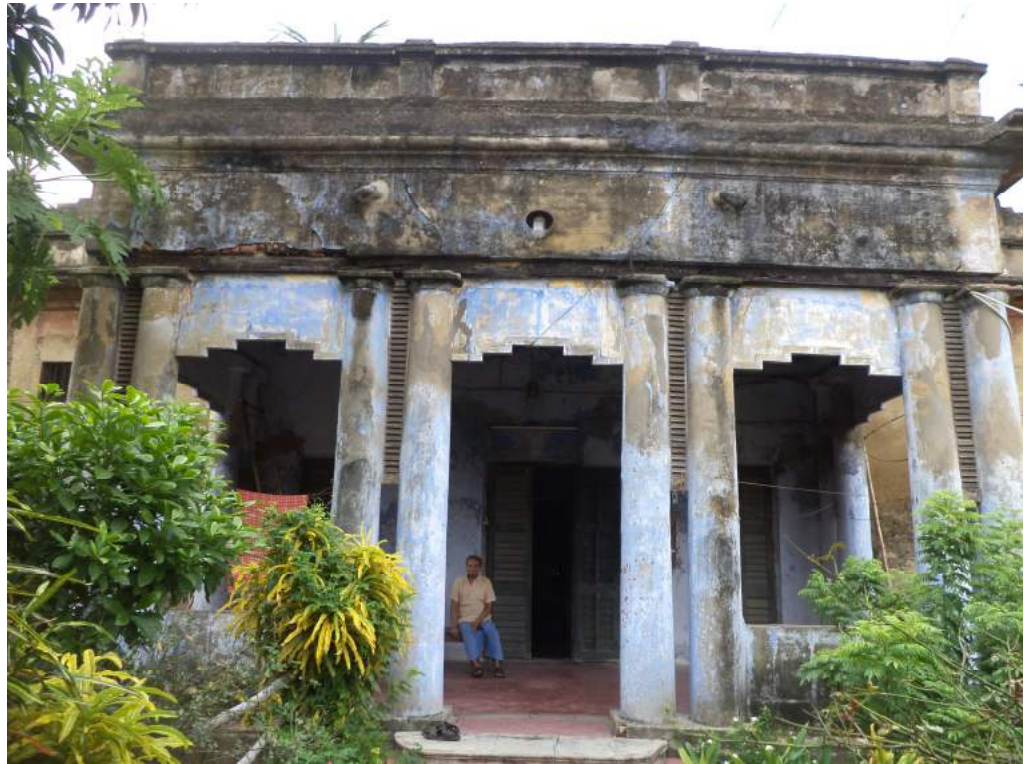
*View from  
entrance*

<b>Address</b>	: 51/52 Panchugopal Bhaduri Sarani, (Previously known as Gantzer Street)
<b>Ownership</b>	: Sitangshu Chakraborty and his nephew
<b>Contact address</b>	: 51/52 Panchugopal Bhaduri Sarani, (Previously known as Gantzer Street)
<b>Description of typology</b>	: European bungalow typology
<b>Year of construction / age</b>	: More than 150 years
<b>Associated history</b>	: Reverend Lee Philipant (Sub-Judge of Serampore) sold the building to Charubala Devi, mother of Sitangshu Chakraborty.
<b>Previous and existing utilization</b>	: Residential
<b>Architectural and special features</b>	: Classical European bungalow with a lofty front portico and central hall flanked by rooms on two sides. Height of rooms is about 20 feet. Wooden beams supporting the tile roof with lime terracing.
<b>Condition assessment</b>	: Poor maintenance with dampness observed in walls and roofs.
<b>Statement of conservation significance</b>	: High conservation significance for historic and architectural importance.

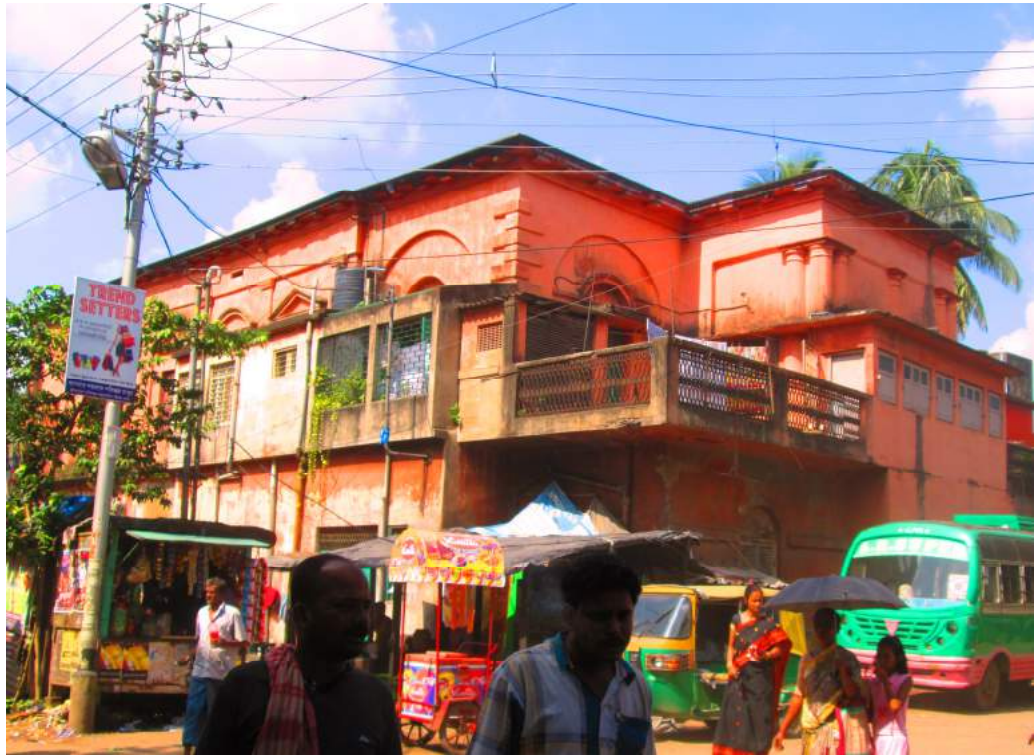
*Residence of Pal Family*

<b><i>Condition assessment</i></b>	: Fairly good structural condition but poor maintenance. Additions and alterations led to loss of architectural and historic identity. Encroachment by stalls and bus parking blocking clear view from the North Gate of court compound and church square.
<b><i>Statement of conservation significance</i></b>	: High conservation significance in terms of historical, architectural, and locational importance due to its position abutting church square and proximity of court compound.
<b><i>Grade</i></b>	: IIA

*View from  
North West*

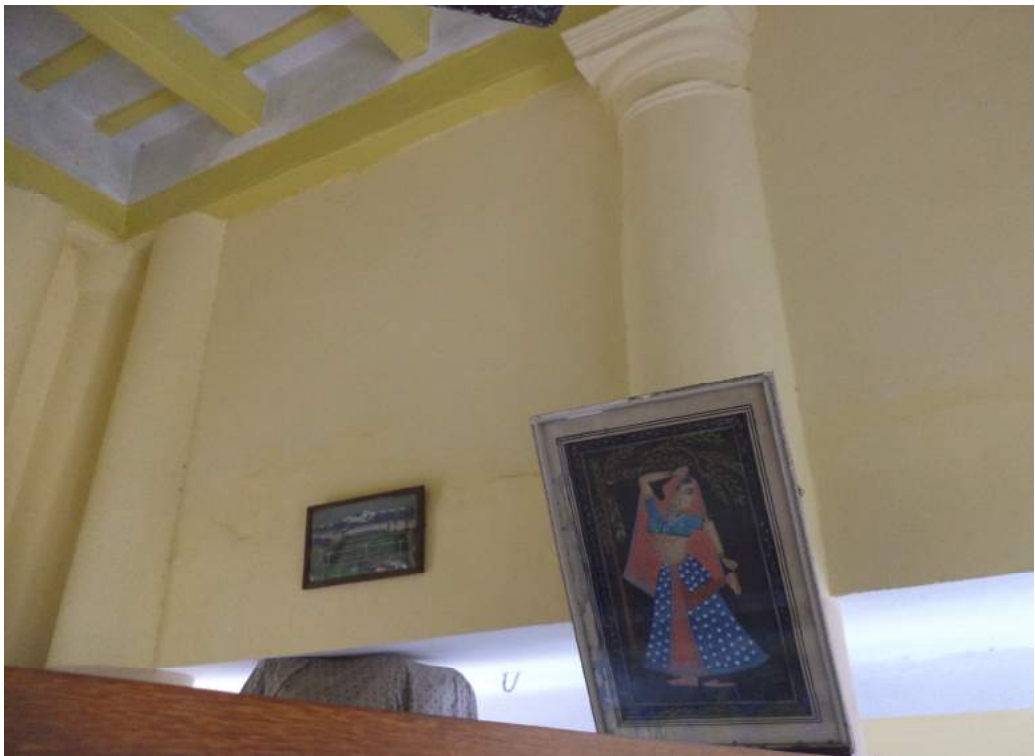
*View of the  
ceiling of a  
present bed  
room*

<b><i>Address</i></b>	: 50, N. N. Roy Street
<b><i>Ownership</i></b>	: Debabrata Pal and six others
<b><i>Contact address</i></b>	: 50, N. N. Roy Street
<b><i>Description of typology</i></b>	: Classical European villa typology
<b><i>Year of construction / age</i></b>	: More than 150 years
<b><i>Associated history</i></b>	: The house was built during Danish period. Some old furniture like mirror, table, and wardrobe are found.
<b><i>Previous and existing utilization</i></b>	: Previously, the first floor was utilized for residential purpose and ground floor was rented out for commercial purpose (State Bank of India, marriage registration office). Currently, the SBI branch has been shifted. Marriage registration office has been temporarily placed in the rear side of the house premises. At present owners stay in first floor while the ground floor is lying vacant.
<b><i>Architectural and special features</i></b>	: Height of rooms is about 20 feet. Clearstory windows observed. Wooden beams, 20” thick brick wall with ghensh mortar. Large wooden stair replaced by concrete stair. New rooms and toilets have been added afterwards. Old furniture (mirror, table, and wardrobe) of classical design observed in the house.

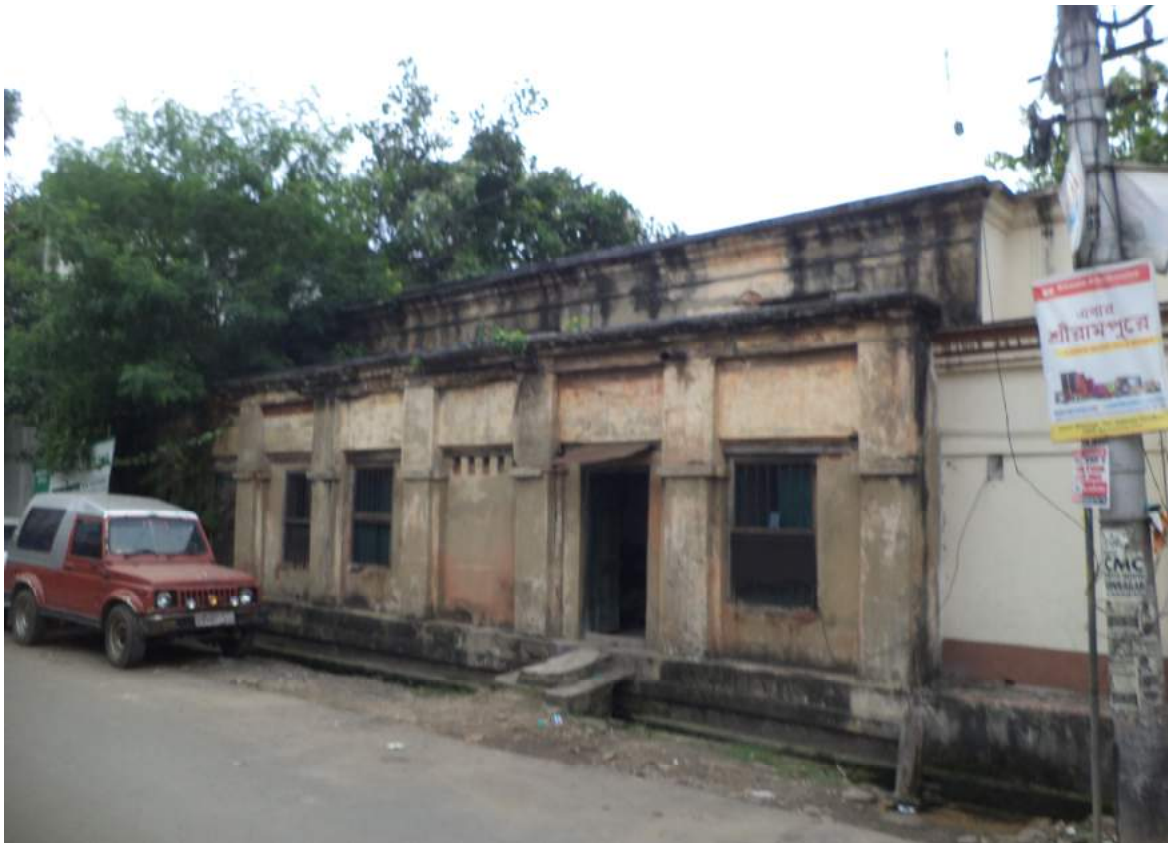
*Old Police Residence (View from K. M. Sha Street)*

<b><i>Address of the House</i></b>	:	K.M. Sha Street
<b><i>Name of the Owner(s)</i></b>	:	Police Department, Govt. of West Bengal
<b><i>Contact Address</i></b>	:	K.M. Sha Street
<b><i>Description of typology</i></b>	:	European modified bungalow typology
<b><i>Year of construction / age</i></b>	:	About 100 years
<b><i>Associated history</i></b>	:	-
<b><i>Previous and existing utilization</i></b>	:	Police barrack
<b><i>Architectural and special features</i></b>	:	European bungalow typology
<b><i>Condition assessment</i></b>	:	Fairly good condition of structure but inadequate maintenance
<b><i>Statement of conservation significance</i></b>	:	European bungalow typology with a large pond in the middle lends pleasing visual order to the K.M. Sha Street
<b><i>Grade</i></b>	:	IIB
